Confidential Inspection Report

Tuesday, October 17, 2023

Inspector, Anton E. Britting
J.P.I. Inspections, LLC

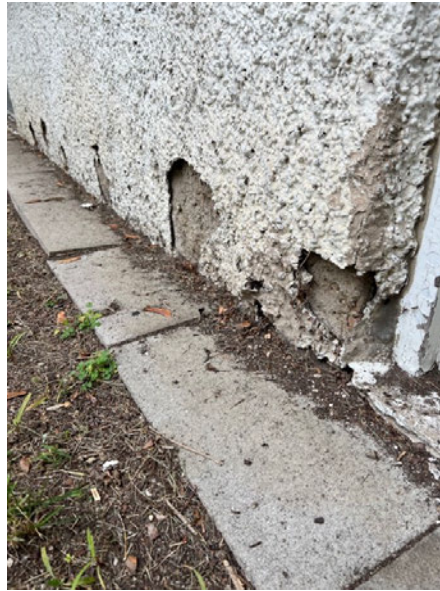
FOUNDATION

WARN The parging/stucco technique performed on portions of the exterior foundation is substandard, and is failing. The repairs performed have Deteriorated and crumbled, presumably from substandard installation techniques.

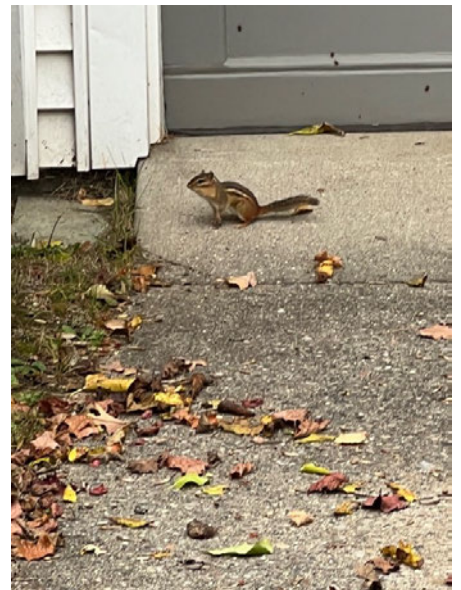
PEST CONTROL

Rodents have been active in the yard in the past. It is possible there is no current infestation. We recommend that bait or traps be set and monitored. The advice and services of a licensed exterminator would be recommended if problems persist.

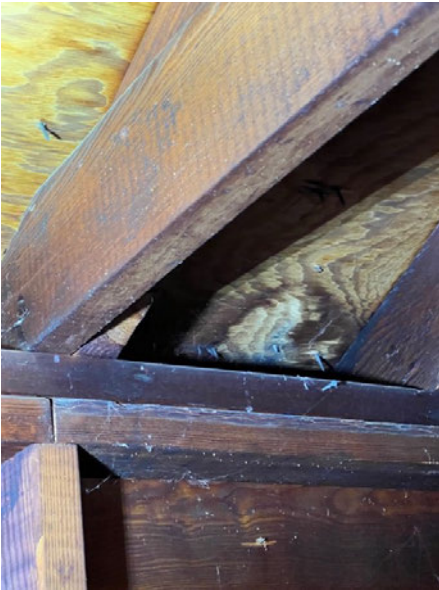
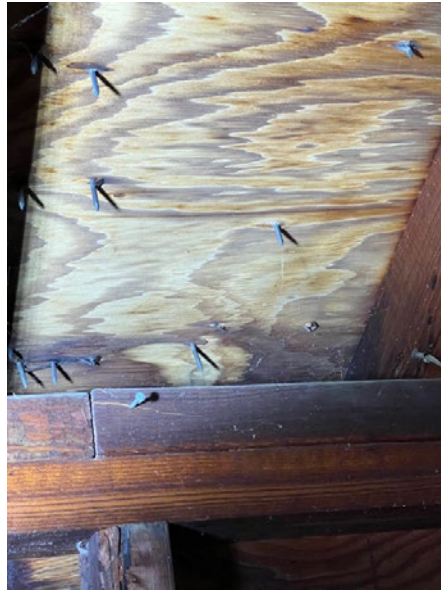
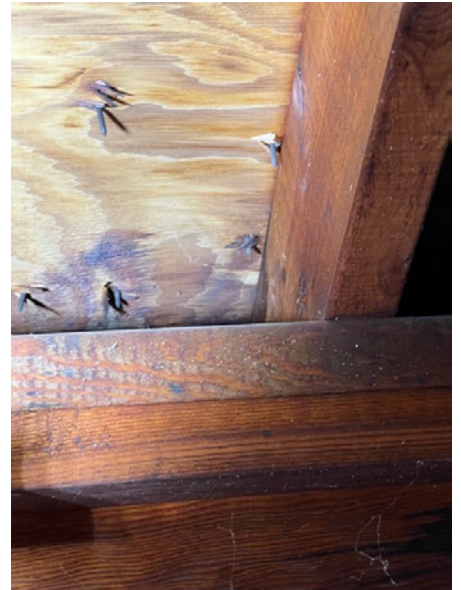
CEILING

There are water stains on the ceiling, but no indication that this is an active leak. No action is indicated, but if additional staining develops the source should be identified and necessary repairs performed.

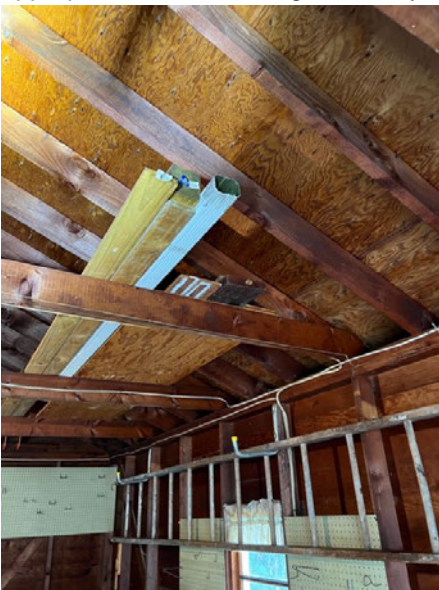
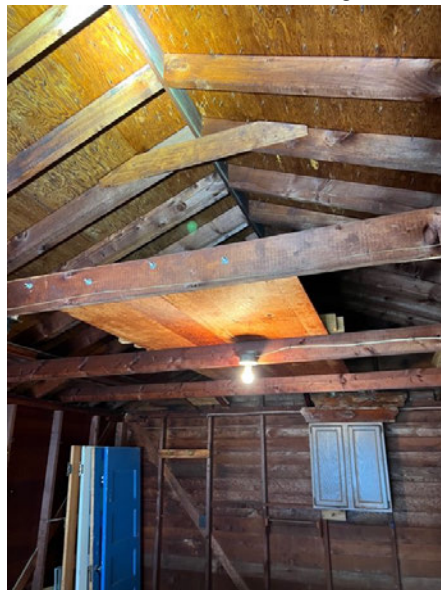
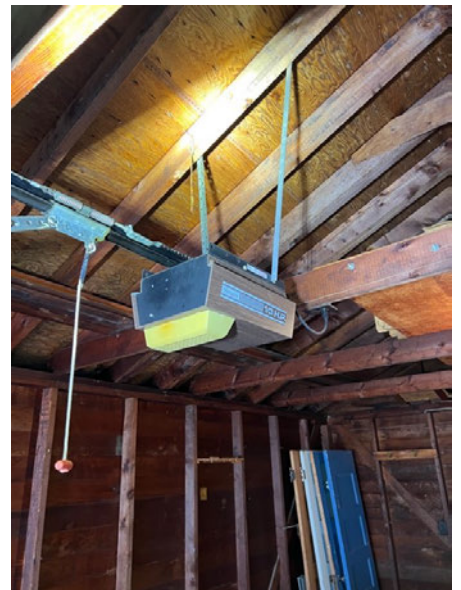
The loft installed in the garage was not designed or constructed to support heavy loads. Storage of light items would be appropriate, but the storage of heavy items such as lumber is discouraged.

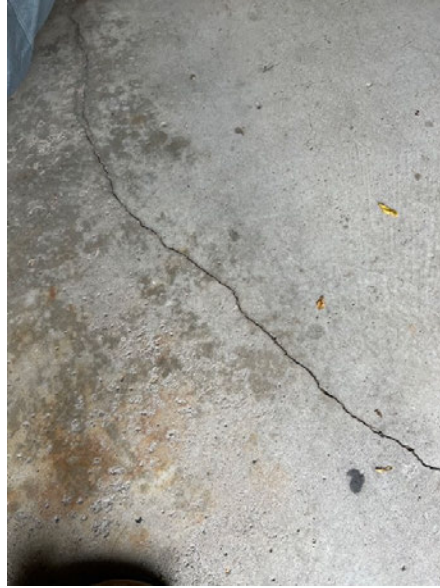
FLOOR

There is cracking in the floor slab but there is no vertical displacement of any portion of the slab. No action is indicated.

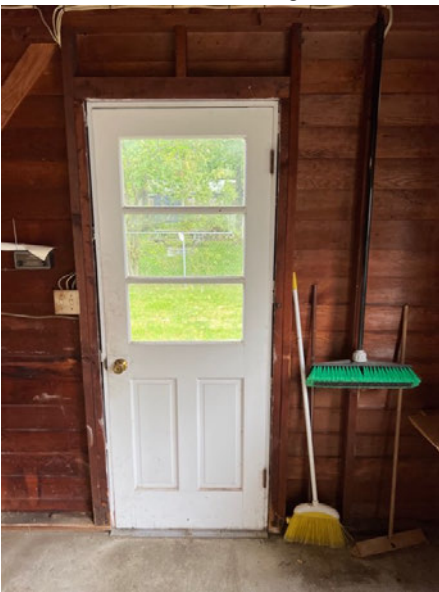
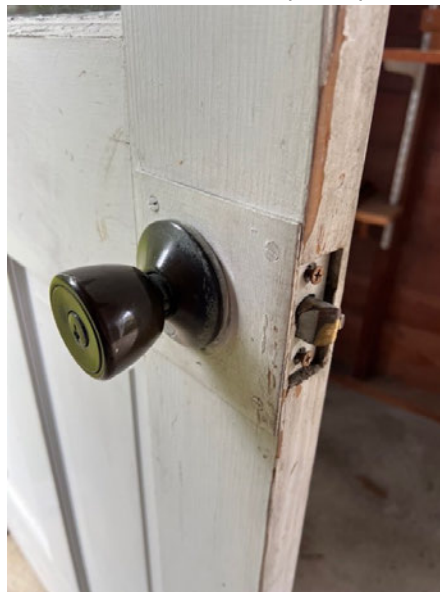
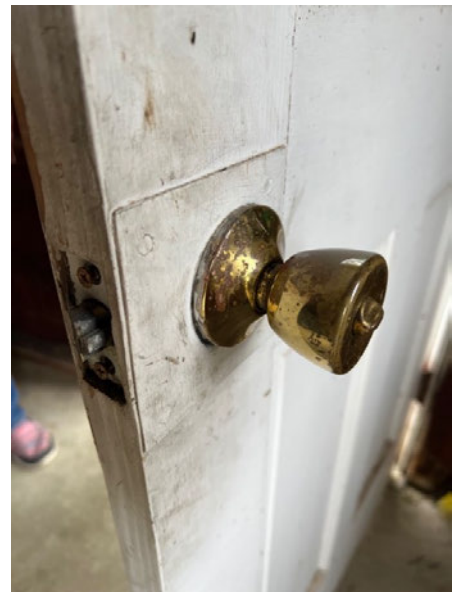
DOORS

The door handle is damaged and will not lock. We recommend repair if possible.

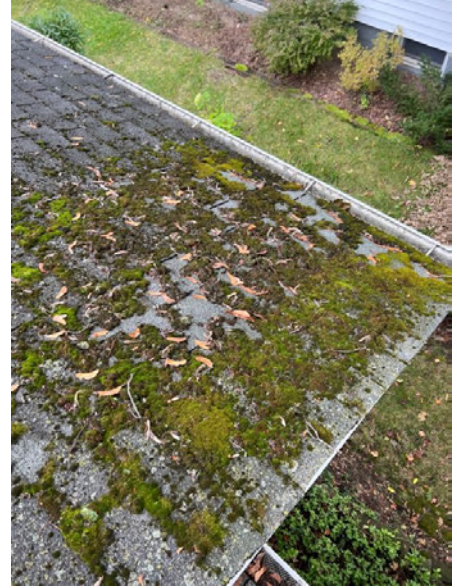
The moss on the ends of the underlying shingles tends to retain moisture and accelerate deterioration over a long period of time. Cleaning and treating the lower edge of the roof will minimize damage to the sheathing and rafter tails.

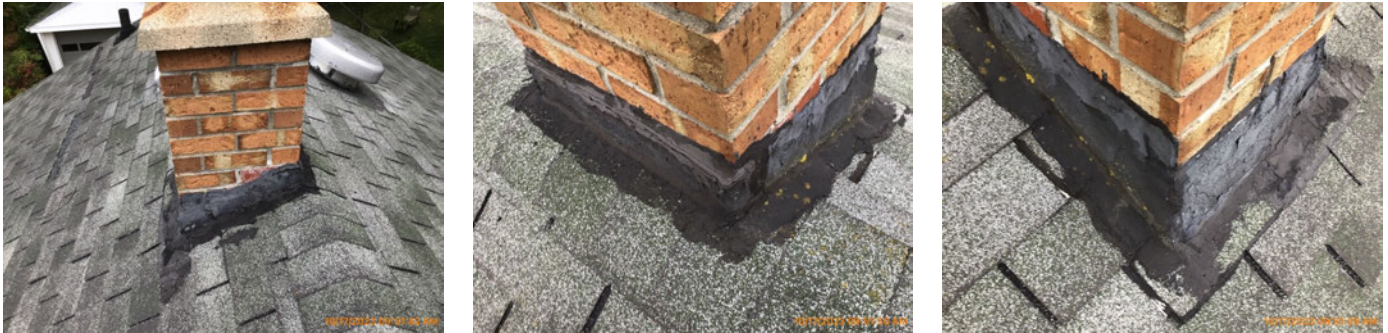
CHIMNEY

A section of the flashing at the chimney is not 'counterflashed' and the opportunity for leakage is apparent. We recommend a counterflashing be installed in accordance with industry standards.

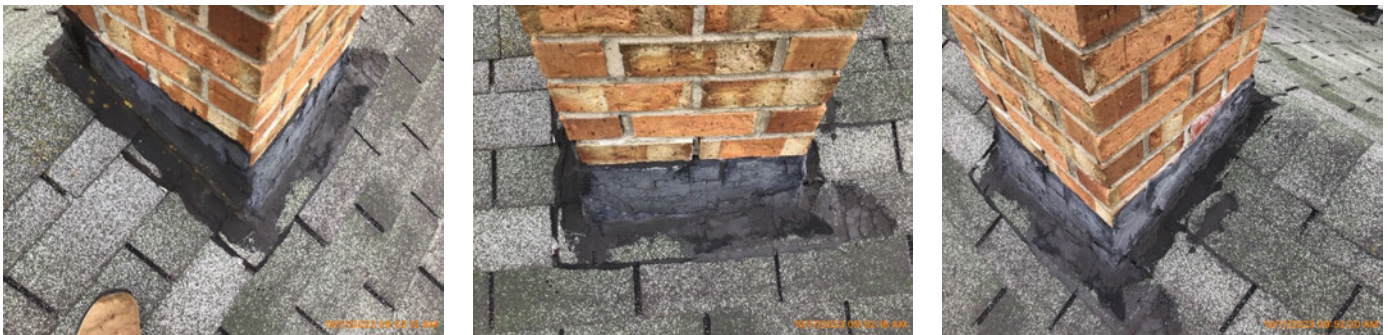
The chimney flashings are in need of maintenance. This maintenance may include replacing rusty fasteners, replacing damaged flashings, reapplying sealants, and/or adhesives and tuck pointing deteriorated mortar

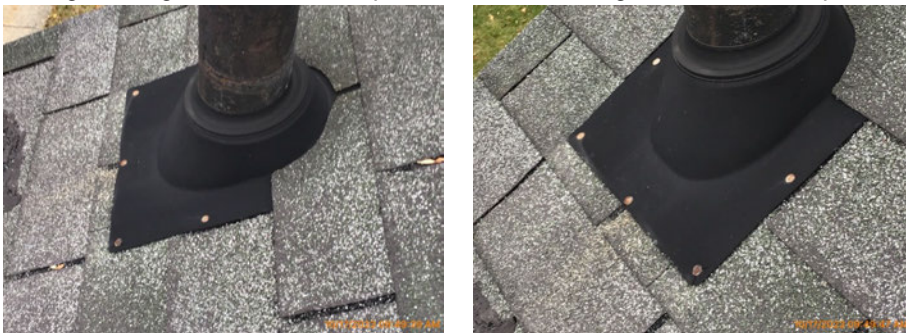
One of the Plumbing vent flashings is improperly installed and conducive to leakage. Upgrade flashing to prevent future leakage. Shingles do not drape around the flashing and there are exposed nail heads.

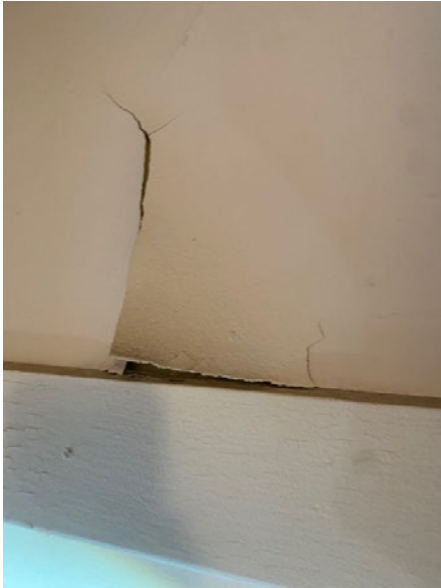
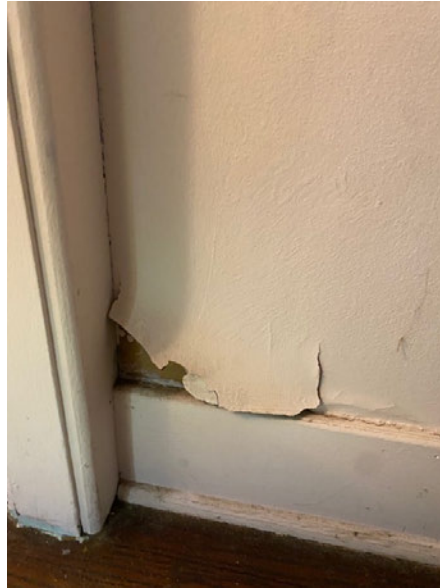
The ceiling in the rear room has an area where it is bulging. We recommend repair.

The front bedroom as some areas where the wall is peeling. We recommend preparing and refinishing.

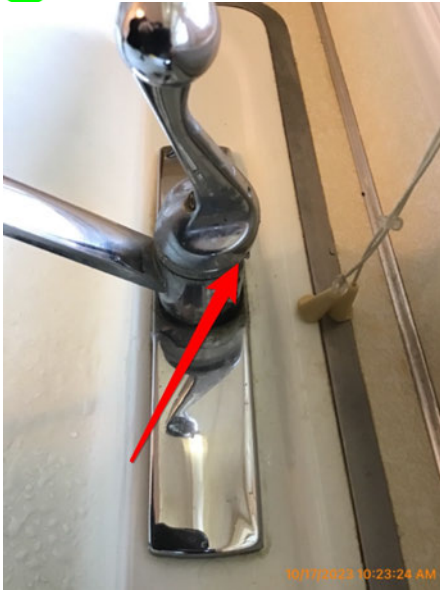
UPG The kitchen faucet is leaking at the handle. We recommend that it be repaired or replaced.

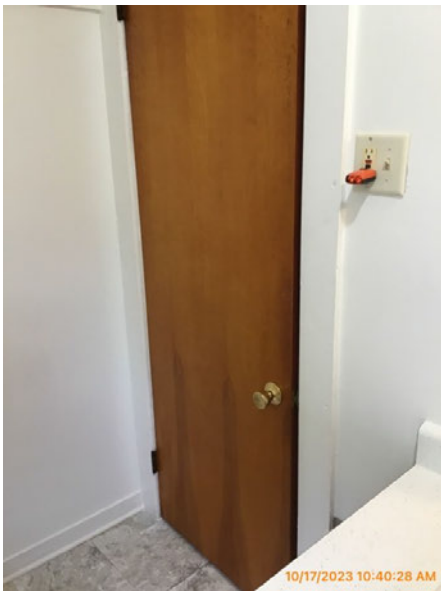
The first floor bathroom door rubs on the frame and does not close. We recommend it be planed or sanded for smoother operation.

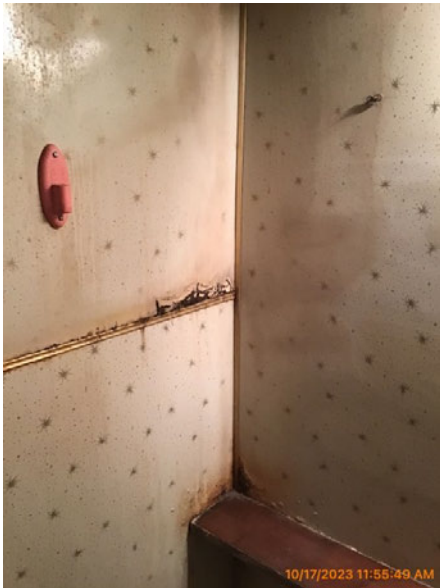
The walls are damaged at the northwest corner. We recommend repair or refinishing.

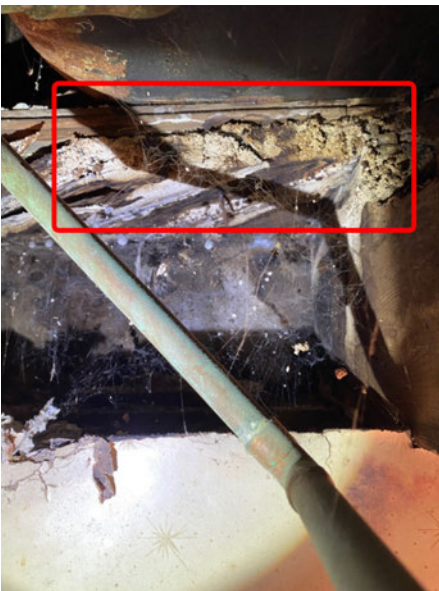
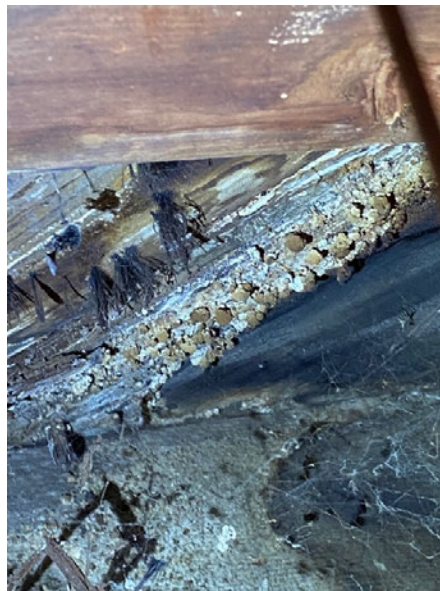
WARN 6: Generally, the subflooring is in good condition. However, the subfloor beneath the shower stall is damaged. There is current fungal growth in this area which should be cleaned and chemically treated. We recommend the subflooring be repaired and all damaged material replaced.

Fungal growth

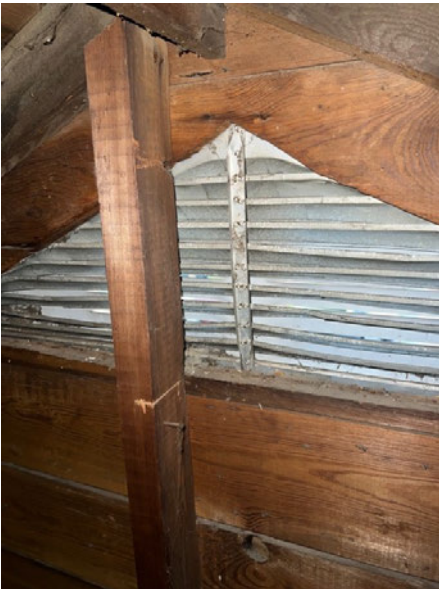
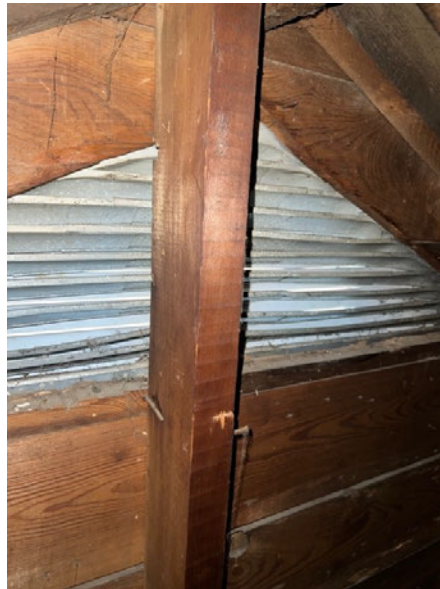
PEST CONTROL

WARN The insect screen on the interior of the gable vent has been torn and should be replaced to keep out insects and pests.

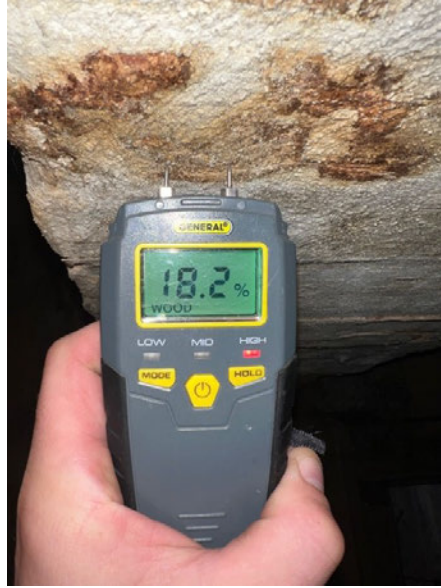
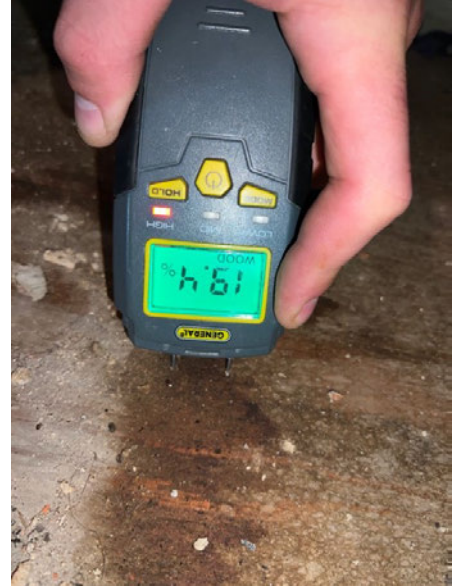
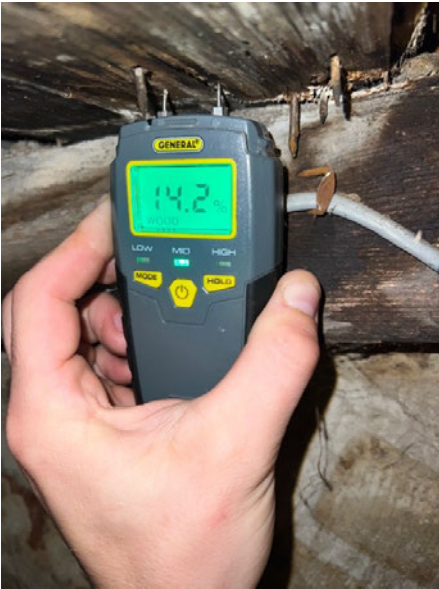
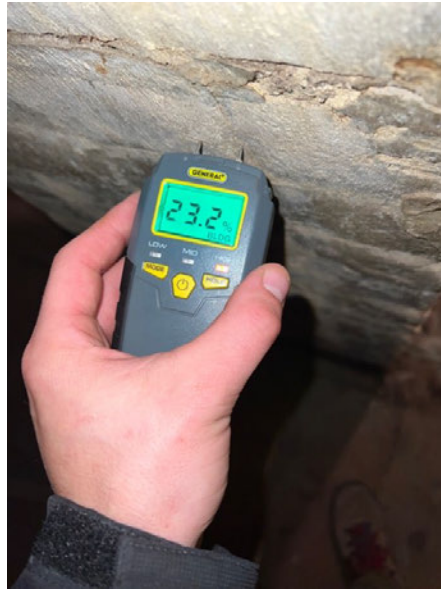
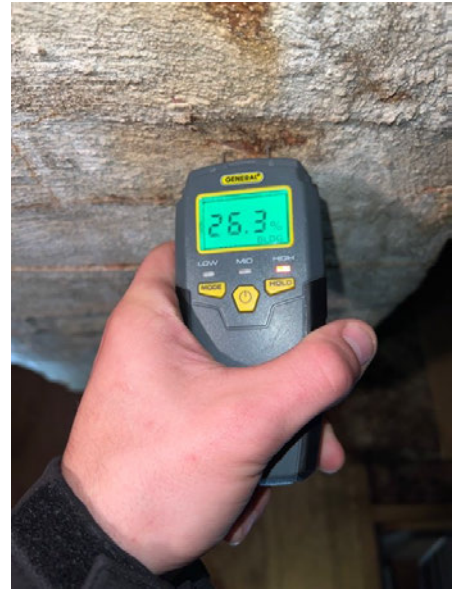
CHIMNEY

The chimney was moist to the touch in the attic.

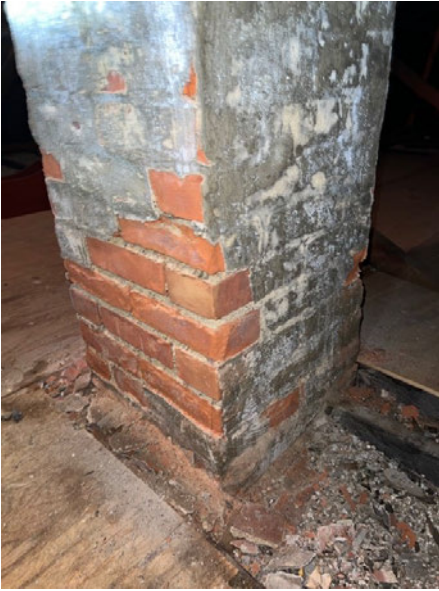
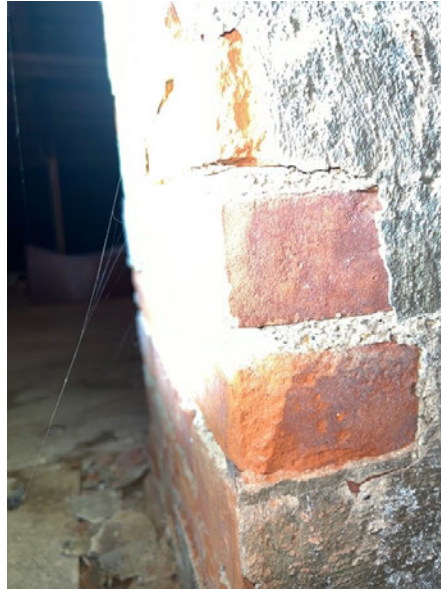
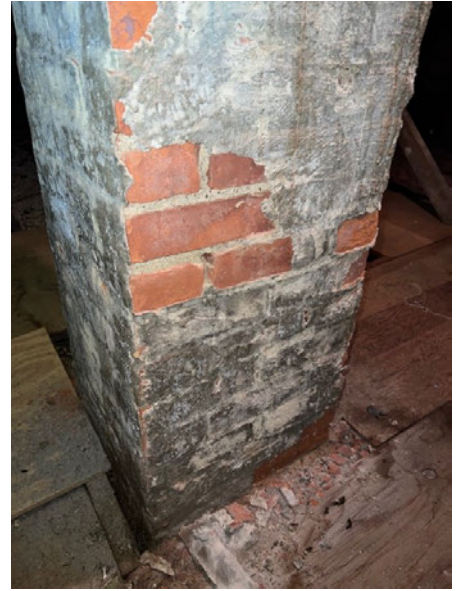
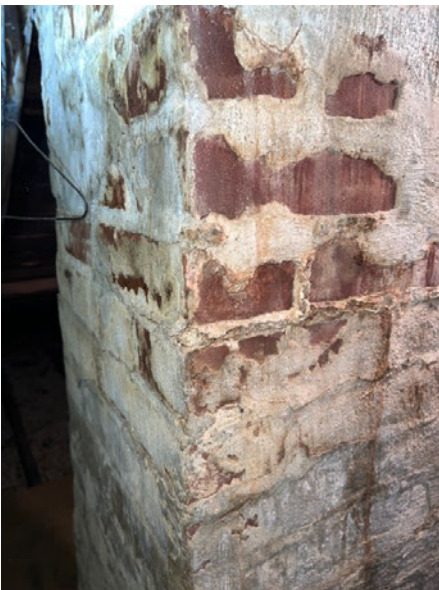
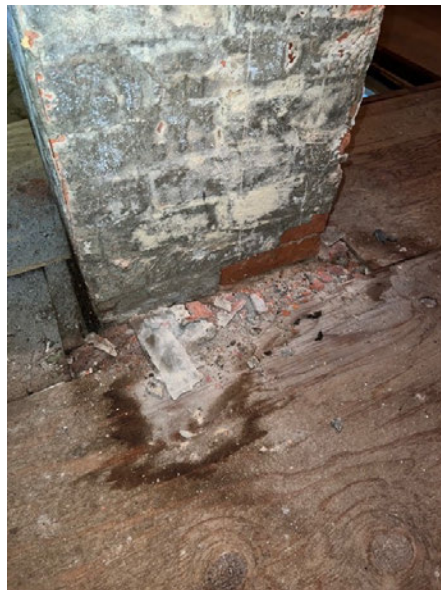
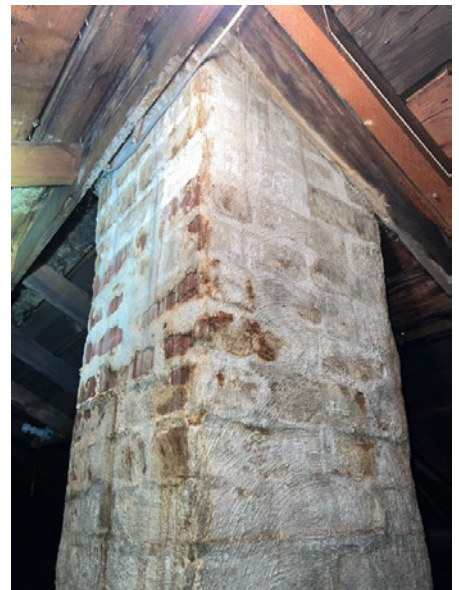
WARN 7: Some leak evidence was apparent around the brick chimney. The exposed brick in the attic has been covered with a cement parging. The cement parging is failing several areas suggesting that moisture is permeating through the brick chimney. We highly recommend attention to flashings around chimney to and tuckpoint mortar maintenance to the brick and mortar above the rooftop as described in the roofing section of this report.

WARN Some leak evidence was apparent around the brick chimney. The exposed brick in the attic has been covered with a cement parging. The cement parging is failing several areas suggesting that moisture is permeating through the brick chimney. We highly recommend attention to flashings around chimney to and tuckpoint mortar maintenance to the brick and mortar above the rooftop as described in the roofing section of this report.

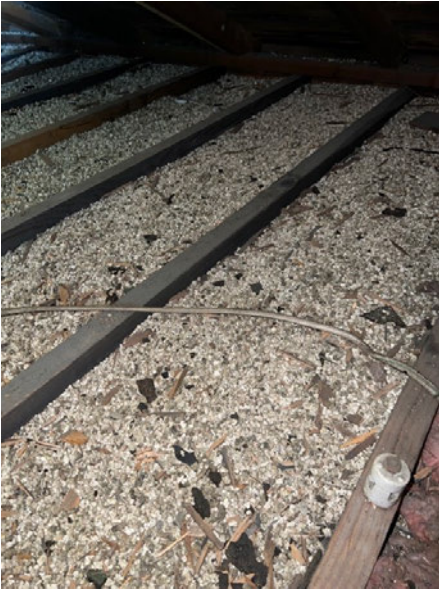
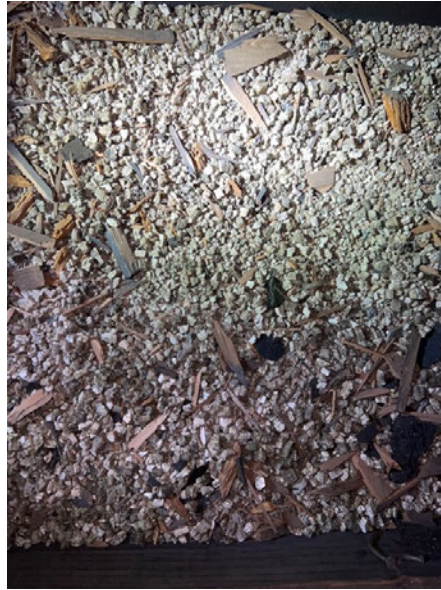
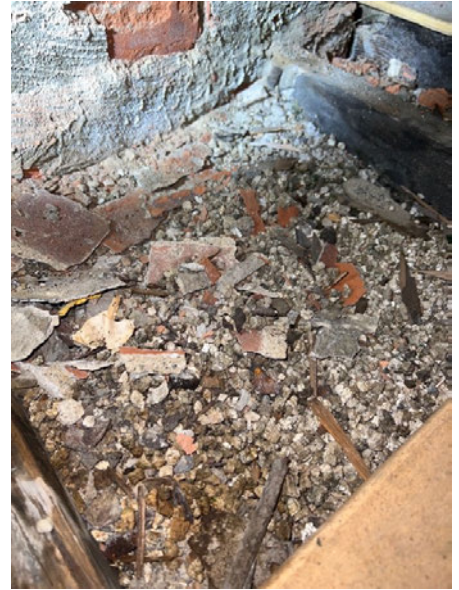
DNGR FHA 8: Most of the attic is insulated with vermiculite. This type of insulation is know to have asbestos. It is recommended that all of the vermiculite be removed from the attic and new cellulose or fiberglass insulation be installed.

Most of the attic is insulated with vermiculite. This type of insulation is know to have asbestos. It is recommended that all of the vermiculite be removed from the attic and new cellulose or fiberglass insulation be installed.
