Confidential Inspection Report

Tuesday, October 17, 2023

Inspector, Anton E. Britting
J.P.I. Inspections, LLC

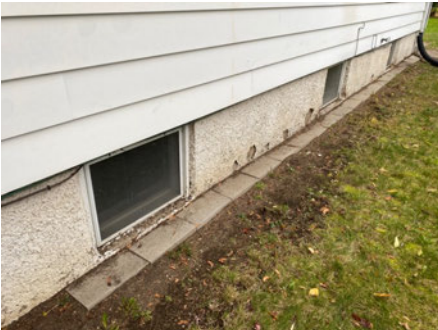
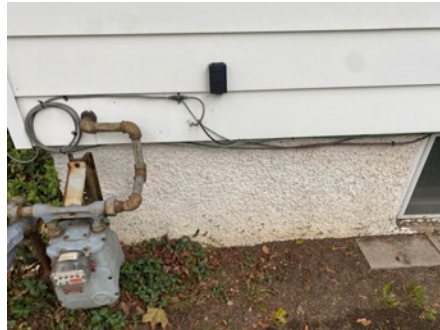
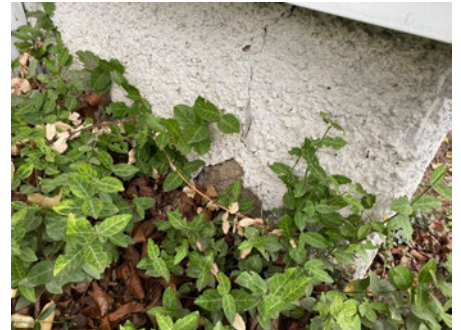
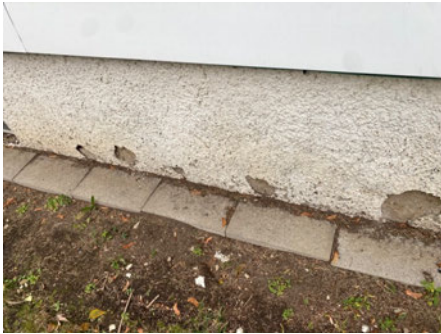
WARN 1: The parging/stucco technique performed on portions of the exterior foundation is substandard, and is failing. The repairs performed have Deteriorated and crumbled, presumably from substandard installation techniques.

WARN The parging/stucco technique performed on portions of the exterior foundation is substandard, and is failing. The repairs performed have Deteriorated and crumbled, presumably from substandard installation techniques.

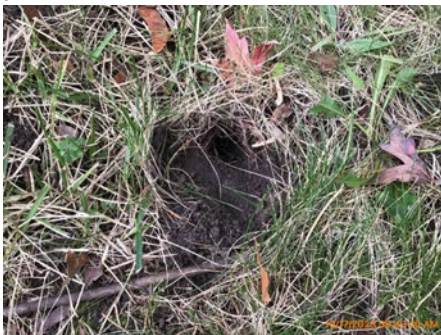
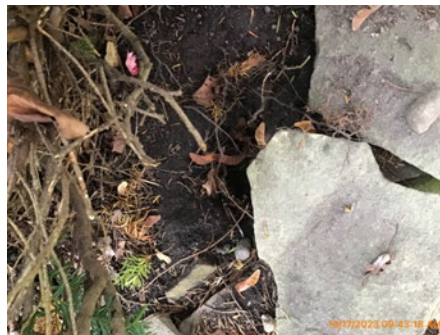
Rodents have been active in the yard in the past. It is possible there is no current infestation. We recommend that bait or traps be set and monitored. The advice and services of a licensed exterminator would be recommended if problems persist.

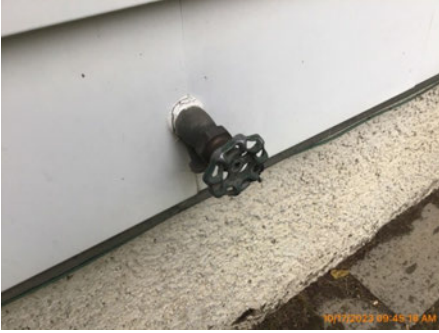
The plumbing on the exterior of the building and in the yard appears to be properly installed and in serviceable condition.

Backflow prevention devices are now required on exterior hose bibs to prevent contamination of the domestic water supply. These devices are inexpensive and available at most hardware stores. Upgrading the hose bibs should be considered.

The hose bibs are not a 'freeze-proof' design. There are interior shutoff valves that should be utilized in the winter to prevent freezing of the exposed pipes. Hose bibs should be drained and hoses removed, drained, and stored.

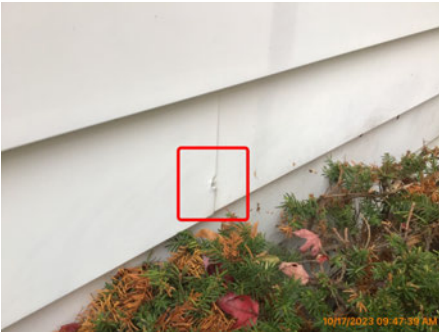
Sections of the aluminum siding at the front are damaged. We recommend they be repaired or replaced.

Small area of damage

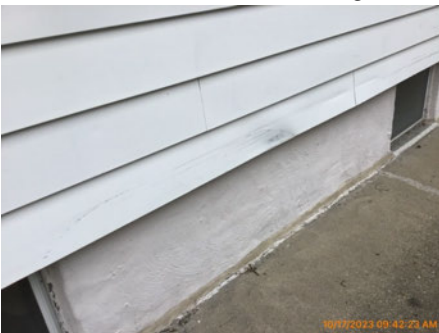
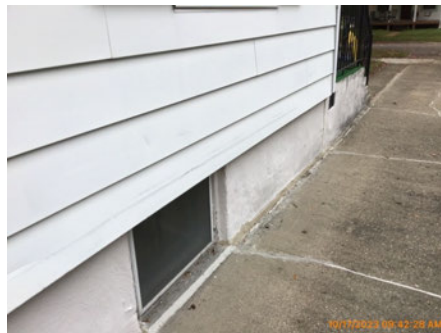
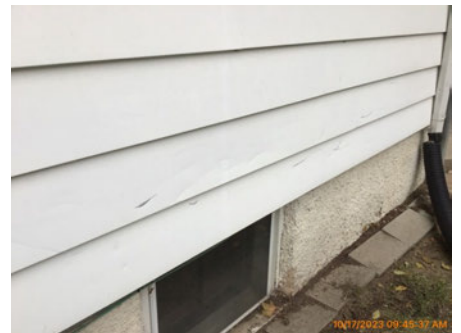
Sections of the aluminum siding are dented. This is a cosmetic condition that can be corrected when convenient.

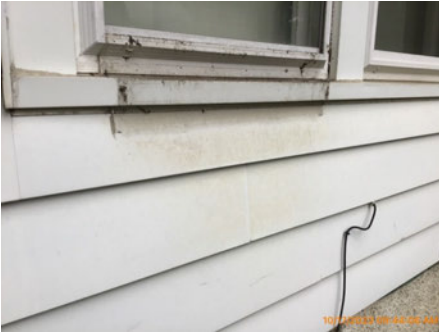
South side

Siding needs to be cleaned.

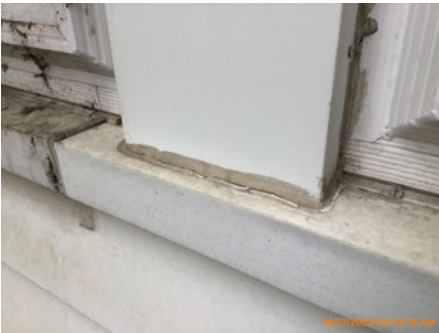
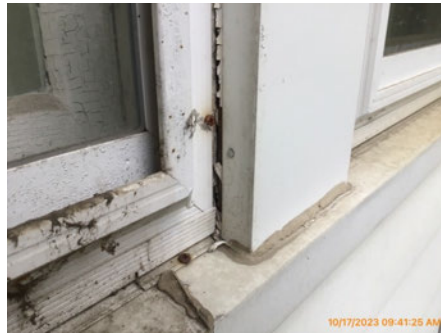
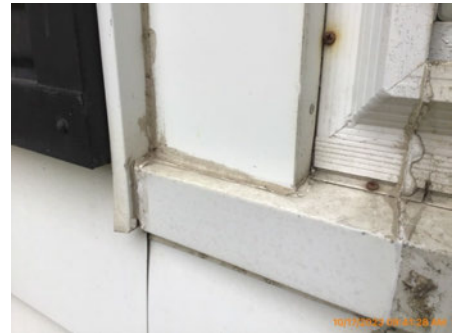
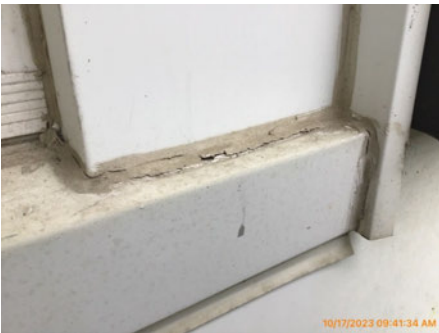
FHA. The window and door trim on this home will need maintenance. This may mean caulking around the window, and or repainting the trim.

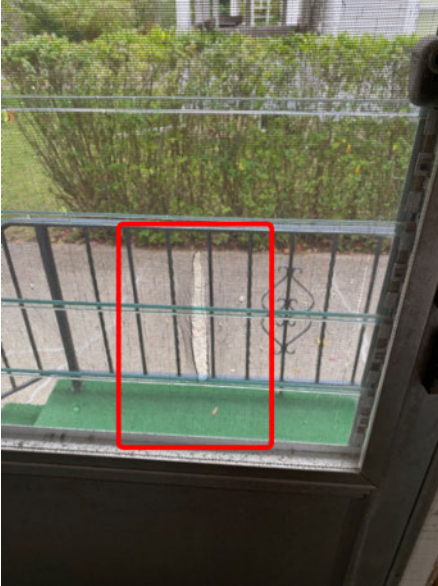
The screen in the porch storm door is torn. The frame appears serviceable but we recommend the screen be replaced.

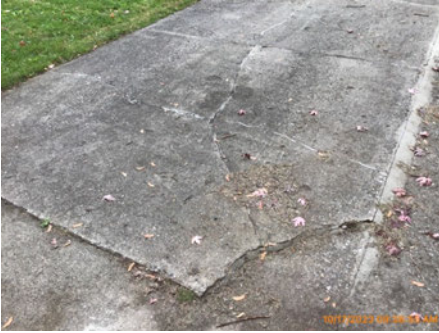
The minor cracks in the driveway are of a cosmetic nature. However, they do indicate movement in the soil and, over time, may develop into an aesthetic issue and/or a safety concern because of tripping hazards.

Cracks have been filled

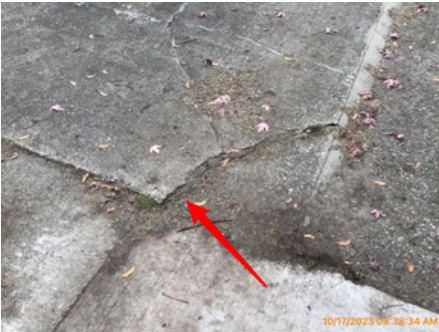
At end of driveway

There are trip hazards in the driveway between concrete slab sections. We recommend they be patched or repaired to prevent injury.

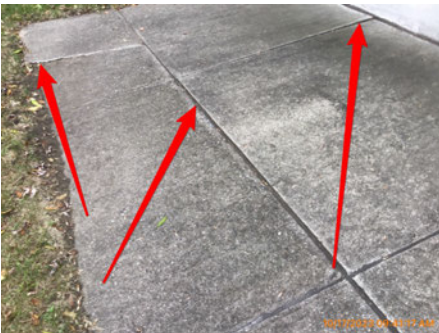
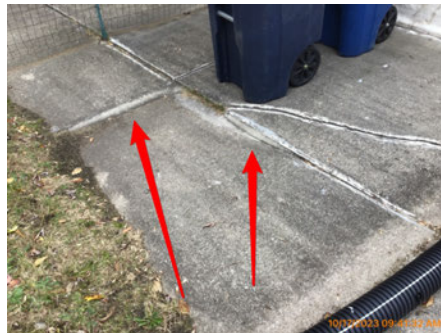
UPG The concrete patio has cracked and settled to the point that it might be considered aesthetically deficient. In our opinion, it is still serviceable and repair or replacement for a better appearance is optional.

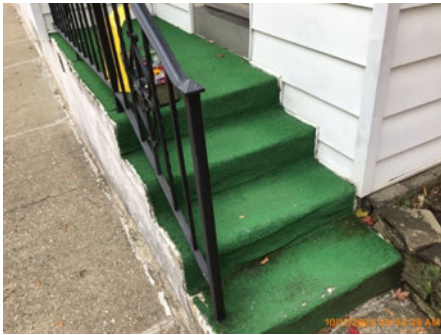
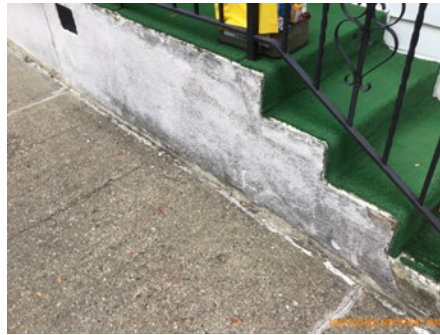
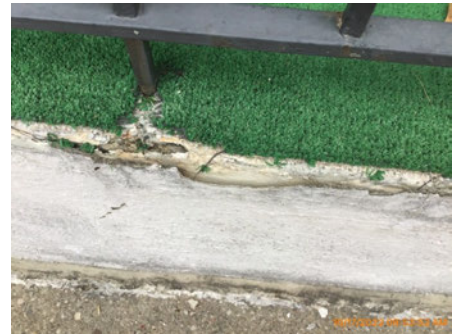
The front porch steps are carpeted limiting our view of the concrete surface. The carpet is coming lose on the rise of the stairs. At this time this is a cosmetic issue.

The parging on the side is coming loose. We recommend repair.

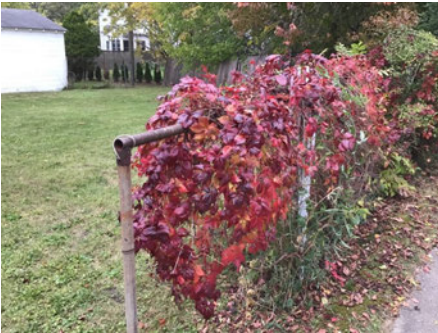
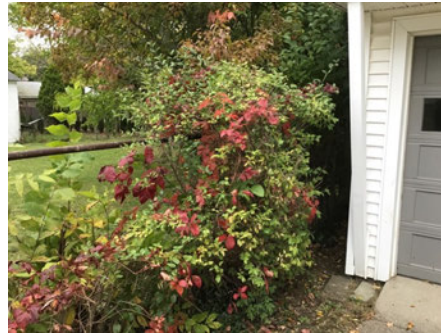
Areas of the property are supporting the growth of poison oak. We did not inspect the property in these areas. We recommend the poison oak be eradicated. At minimum, all residents should be advised of its presence.

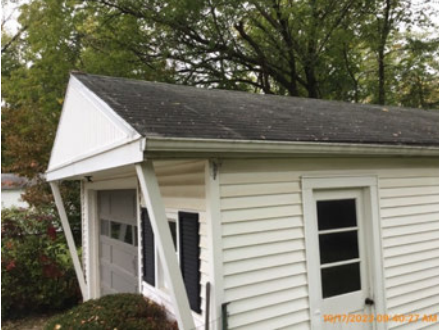
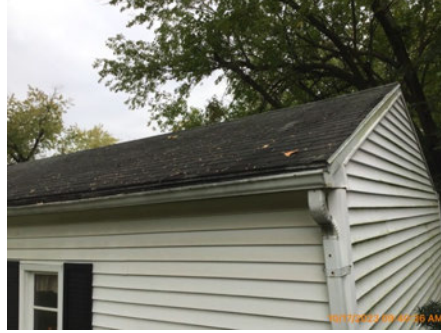
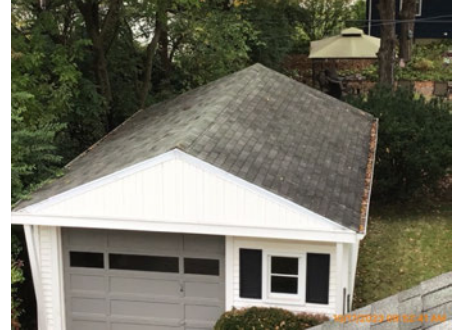
Gutters filled with debris.

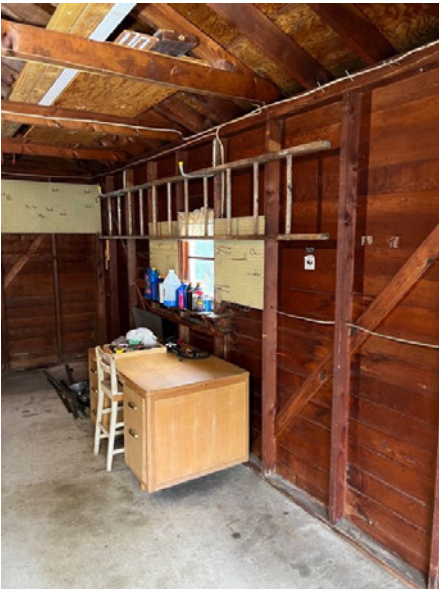
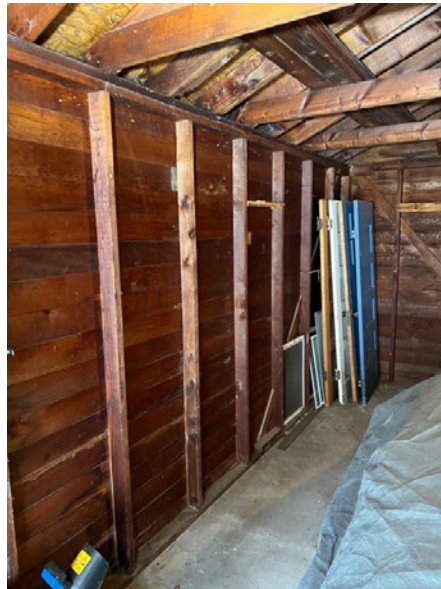
There are water stains on the ceiling, but no indication that this is an active leak. No action is indicated, but if additional staining develops the source should be identified and necessary repairs performed.

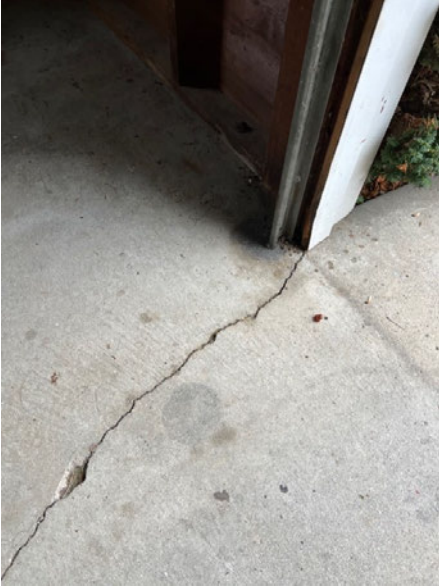
There is cracking in the floor slab but there is no vertical displacement of any portion of the slab. No action is indicated.

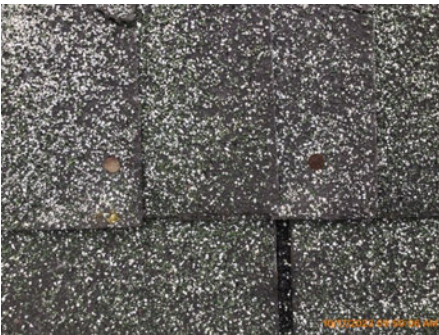
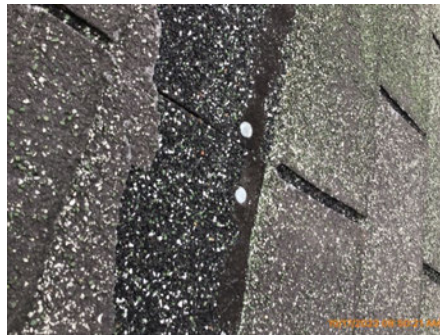
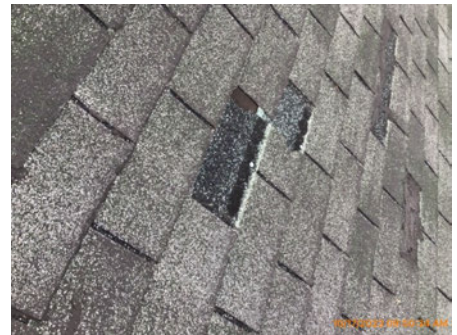
There is extensive surface granulation failure. Many of the shingles have eroded and cracked. These conditions indicate the end of the useful service life of this material.

There are exposed fasteners. These should be sealed with silicone.

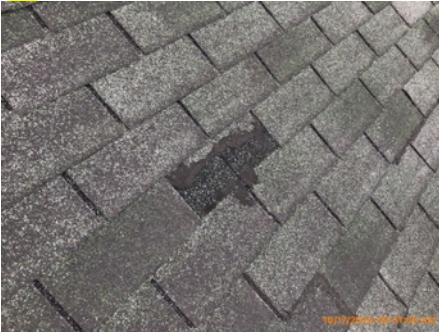
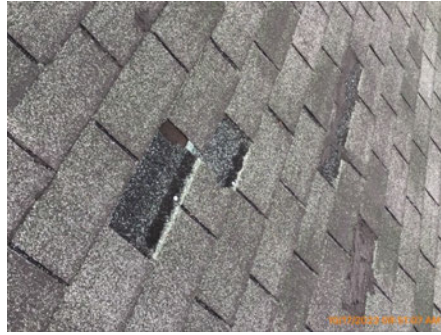
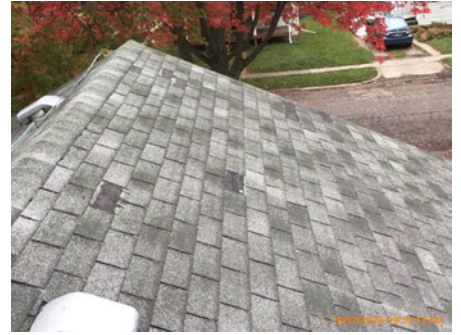
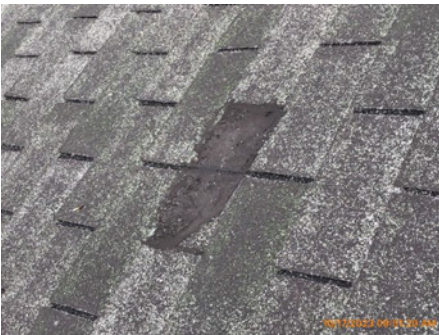
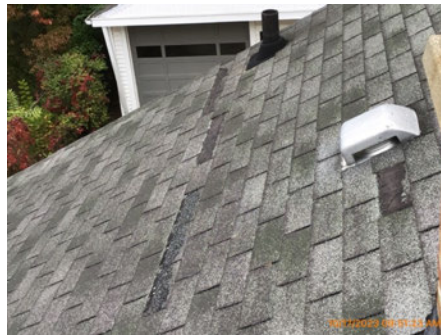
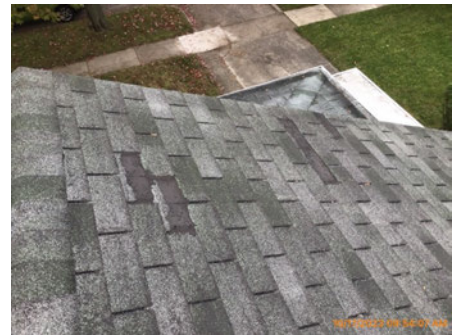
WARN There are a significant number of loose and missing shingles on the ridge and throughout the field.

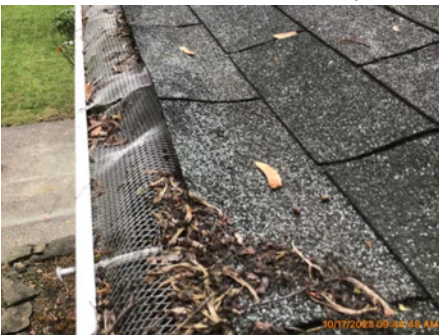
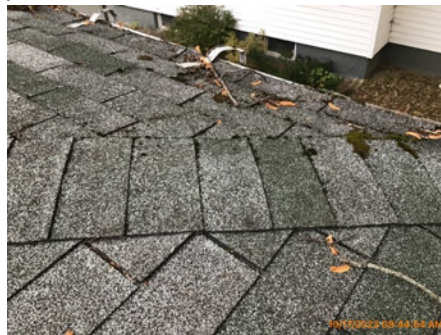
WARN There is debris on the roof, requiring removal to prevent accelerated deterioration of the shingles. We recommend that the roof be monitored and periodically cleared of debris in the course of routine property maintenance.

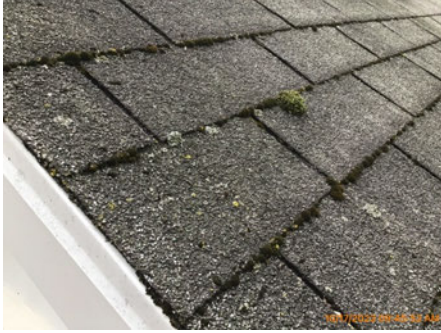
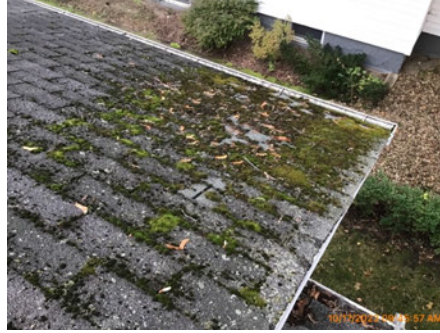
WARN There are trees nearby that will cast debris into the gutters and onto the rooftop periodically. We recommend they be trimmed to prevent debris from accumulating on the roof and to prevent damage by abrasion.

The moss on the ends of the underlying shingles tends to retain moisture and accelerate deterioration over a long period of time. Cleaning and treating the lower edge of the roof will minimize damage to the sheathing and rafter tails.

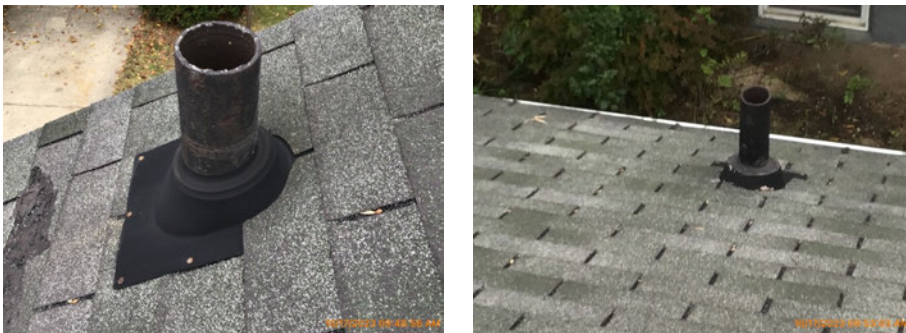
One of the Plumbing vent flashings is improperly installed and conducive to leakage. Upgrade flashing to prevent future leakage. Shingles do not drape around the flashing and there are exposed nail heads.

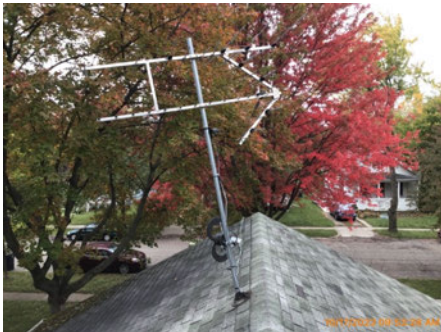
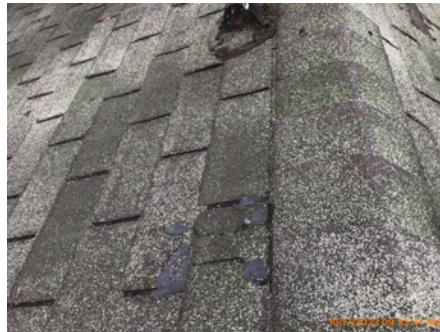
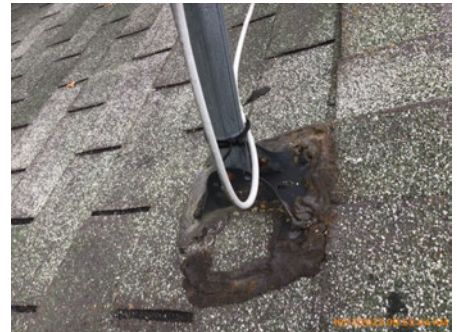
The antenna is serviceable but its mounting bracket has been nailed through the roof. This is not considered a proper installation practice. No leaks were noted, however, and any action would be considered optional.

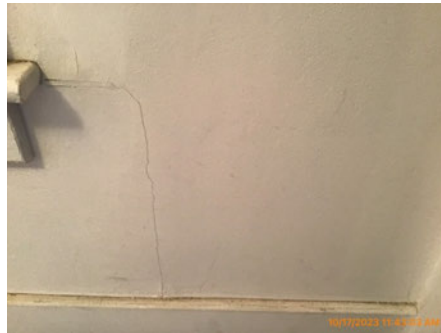
There are minor cracks in the walls and/or ceilings. This is a common condition with this type of construction and does not indicate a structural deficiency. The cracks can be repaired or painted over during routine maintenance.

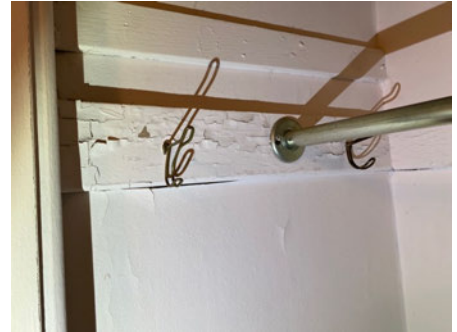
The front bedroom as some areas where the wall is peeling. We recommend preparing and refinishing.

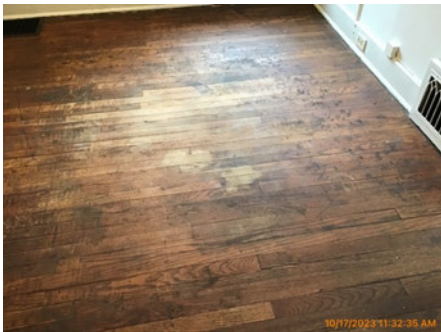
Portions of the floors are worn. We recommend refinishing to protect the wood and for a better appearance.

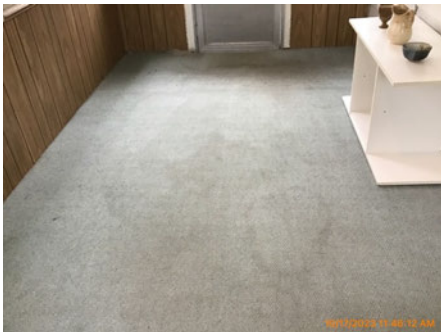
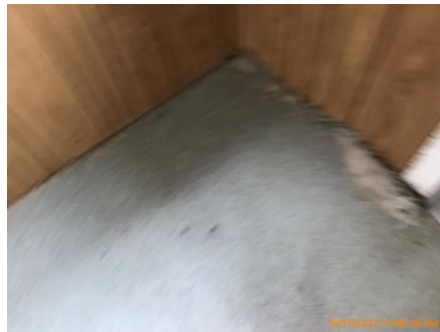
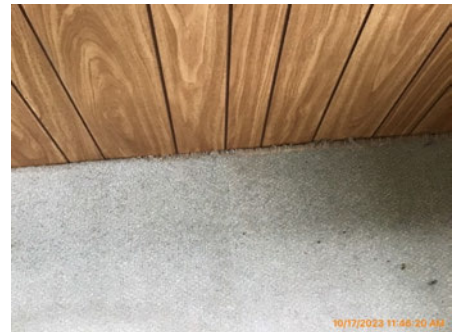
The front porch carpet is generally deteriorated. We recommend repair or replacement.

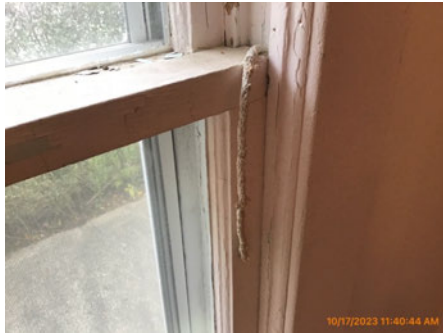
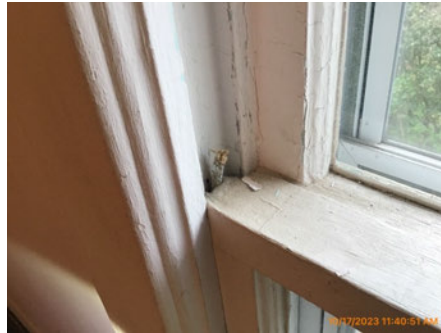
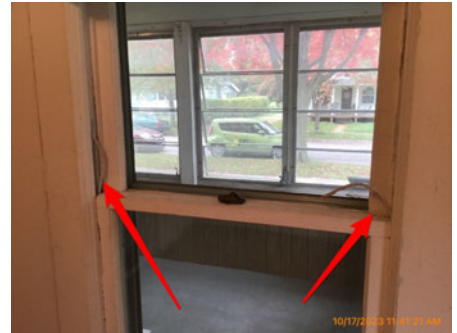
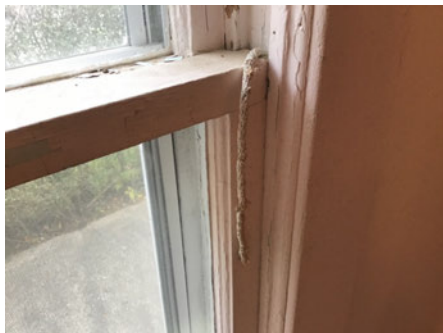
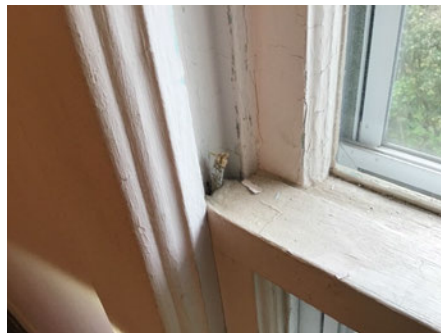
A number of window sash cords are broken and the windows will not stay open. We recommend these windows be repaired and their functional use restored.

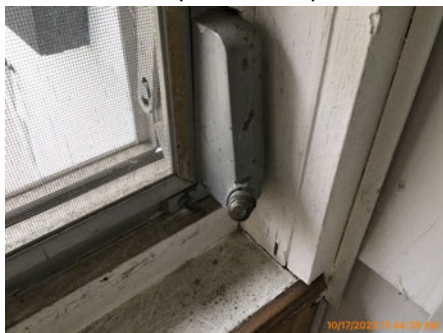
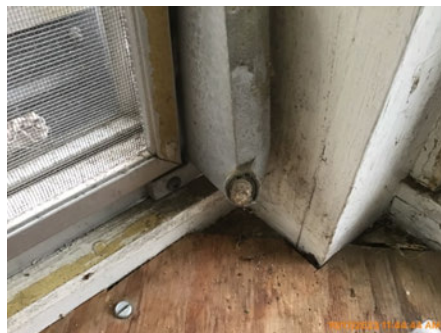
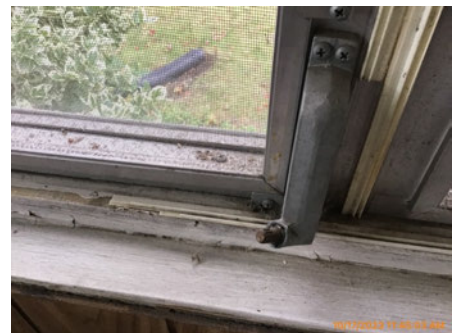
There is broken and/or missing hardware (latches, cranks, etc.) on a number of the windows. We recommend the hardware be repaired or replaced.

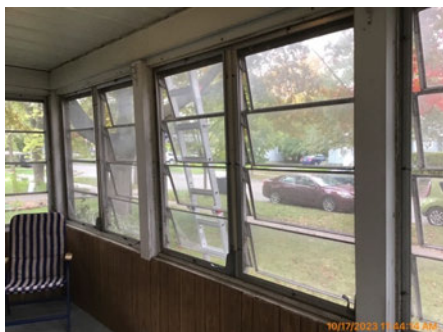
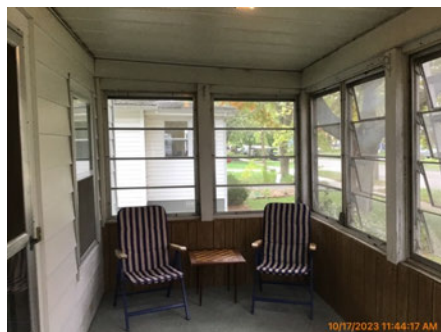
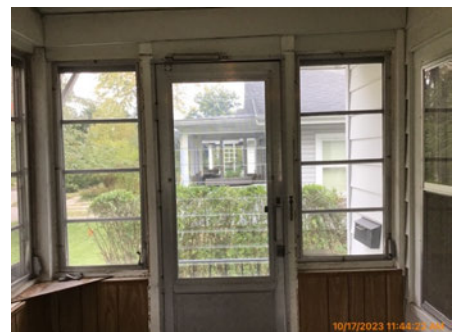
The existing 'jalousie' type windows are known for their poor security and energy conservation characteristics. For these reasons, this type of window is no longer installed in this area. Upgrading is optional but should eventually be considered.

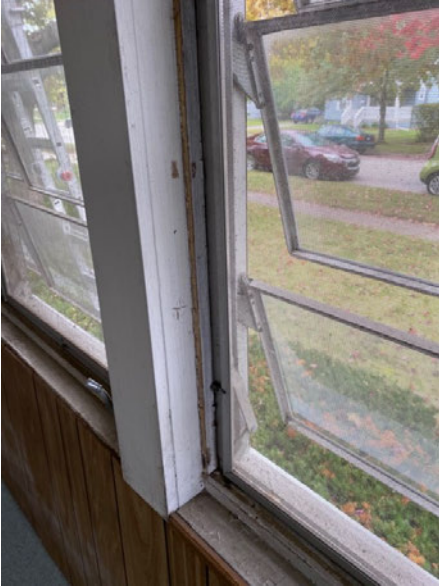
Some of the windows and their frames are in need of refinishing.

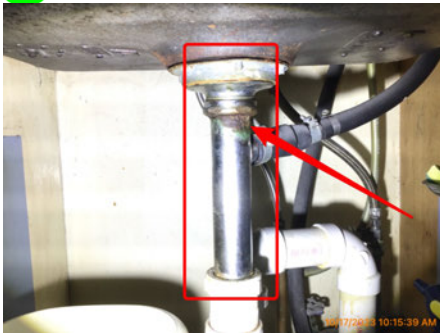
UPG The drain trap associated piping is chromed metal. We recommend replacing these with PVC. Metal will corrode.

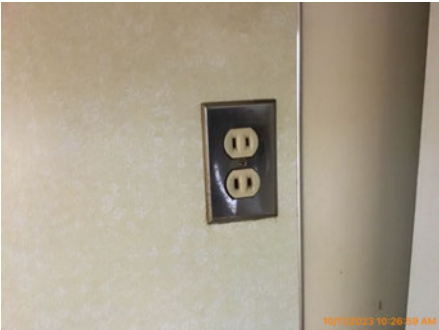
To left of fridge

The receptacle is an ungrounded two prong type. To provide an increased margin of safety, we recommend either the receptacle be repaired and grounded or equivalently protected by adding a GFCI receptacle.

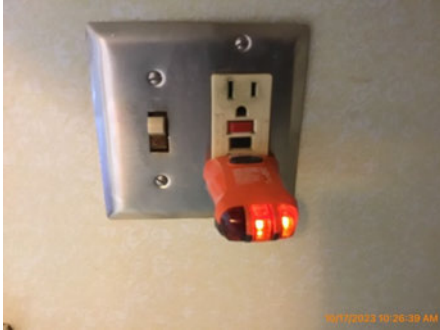
Grounded GFCI to right of sink

GFCI (ground fault circuit interrupter) protection has been installed providing an increased margin of safety. We recommend testing the device on a monthly basis.

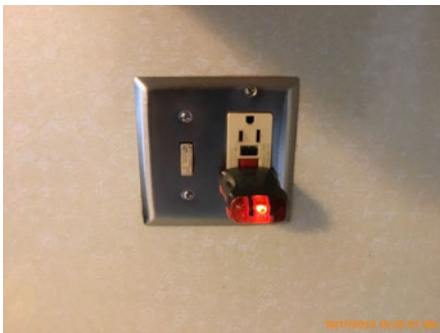
Next to stove

A GFCI receptacle has been installed. This is an approved installation even though the third prong is not connected and the circuit remains ungrounded. The ground fault protection will function and provide a greater margin of safety.

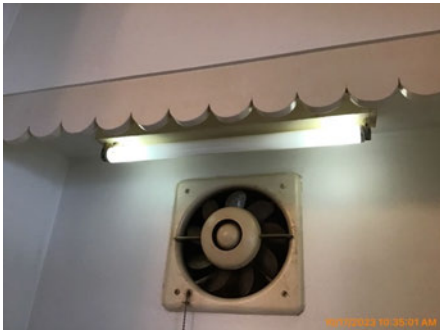
Over the stove

The fluorescent light has a loud hum. This is usually an indication of a bad 'ballast', the transformer within the fixture. This can become a fire hazard. We recommend the ballast or the fixture be replaced.

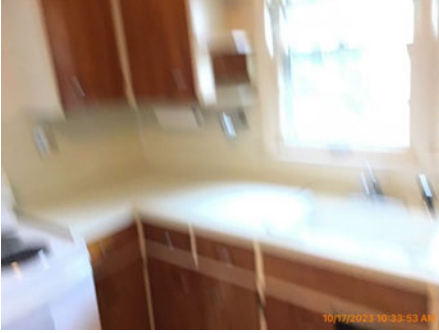
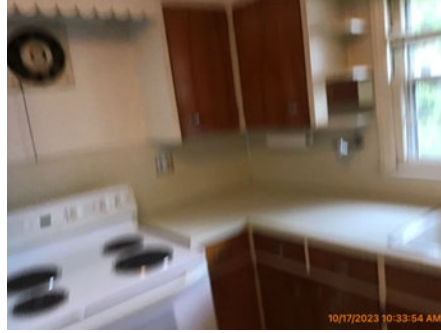
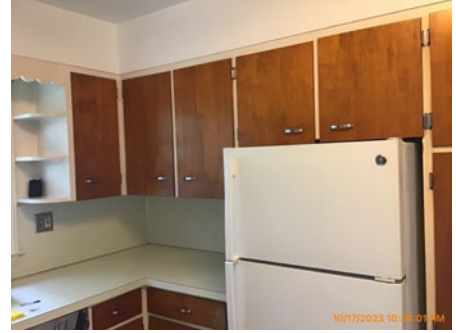
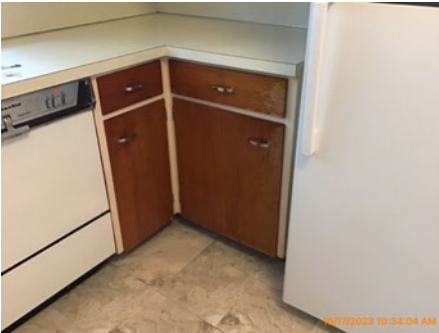
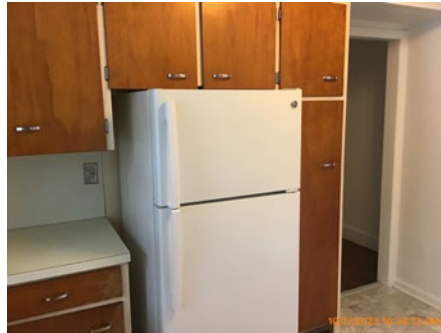
The cabinets are in serviceable condition. Many of the drawers are in need of adjustment for smoother operation.

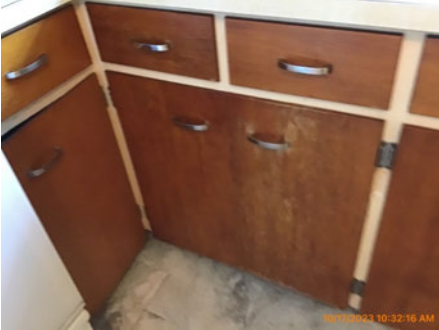
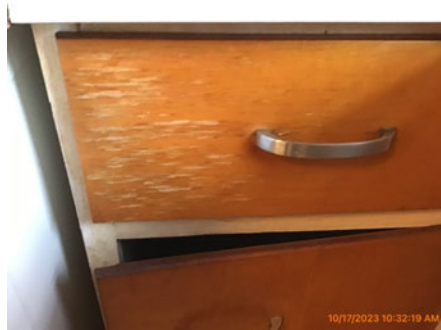
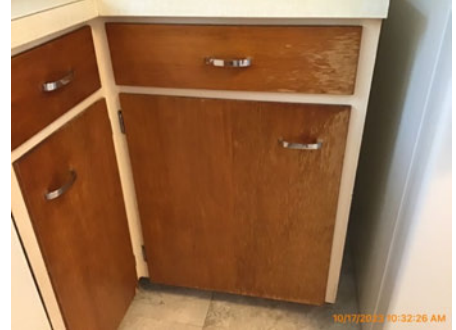
The cabinet surfaces are worn. We recommend they be refinished to restore their cosmetic appearance.

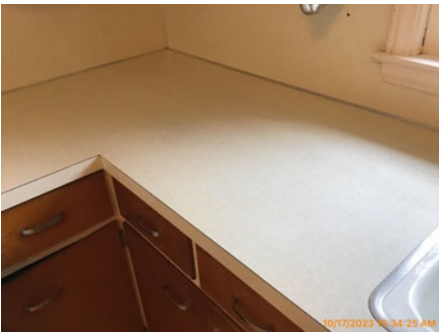
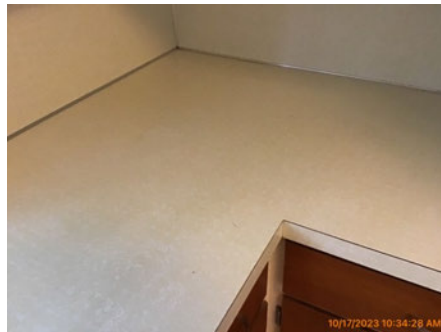
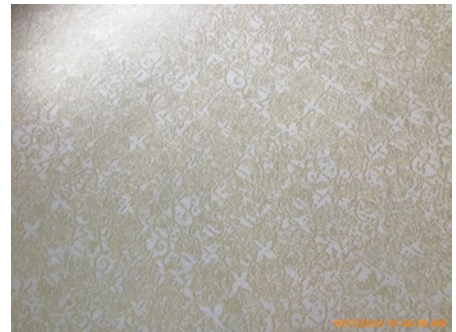
The countertop shows typical wear and tear, normal for this heavily used component. We considered the flaws cosmetic in nature with no action indicated.

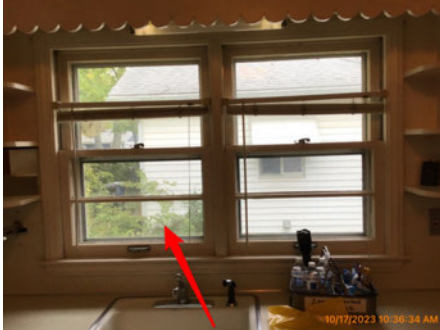
Left window over sink

One or more of the windows do not operate properly because their counterweight spring mechanisms are damaged. We recommend these windows be repaired. We recommend great care when unlatching any windows with broken springs on the top sash.

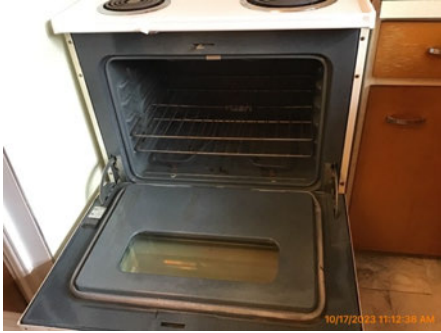
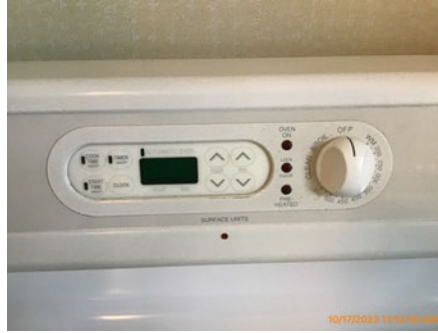
The oven is not functioning properly. The oven display is not displaying any numbers or status. Although the Stove top was operating we recommend the services on the oven, appliance technician to restore the functionality of the oven and display.

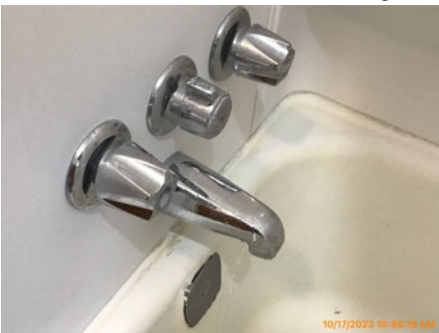
The shower/tub diverter is missing and/or damaged. We recommend repair.

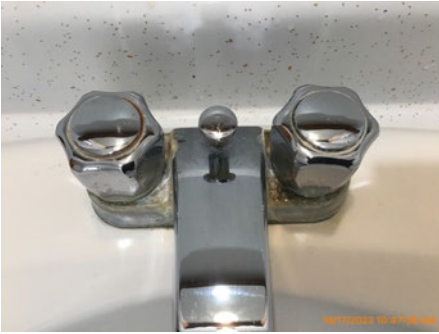
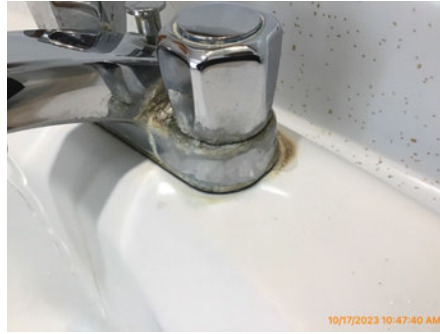
The sink faucet has visible corrosion. We recommend replacement.

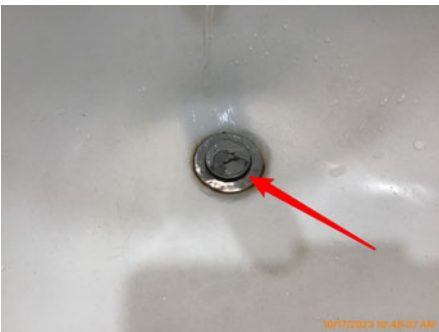
The drain stop is defective. We recommend it be repaired or replaced.

Does not fully open

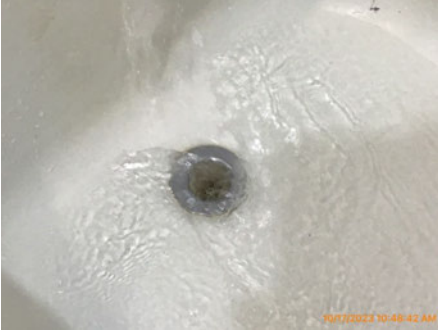
The drain stop is missing. We recommend it be replaced.

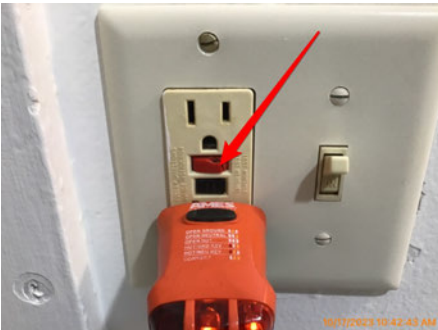
There is a damaged receptacle. We recommend it be replaced.

Reset button damaged

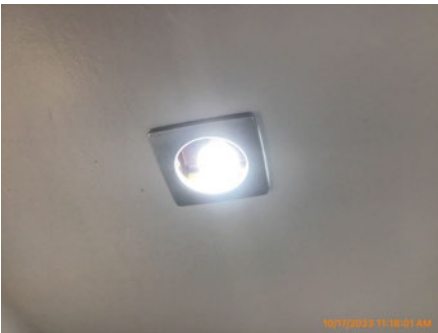
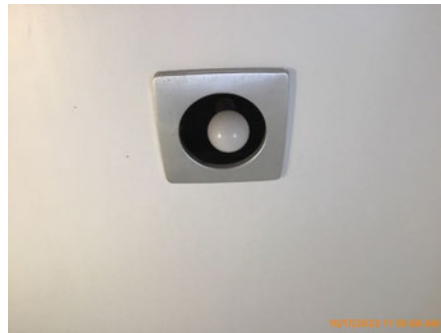
The ceiling light is missing its cover.

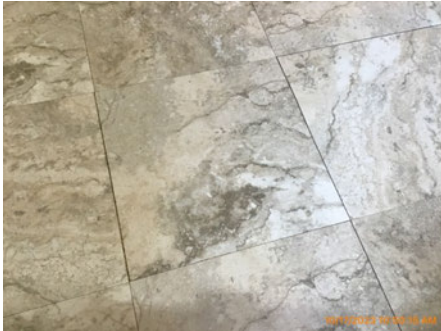
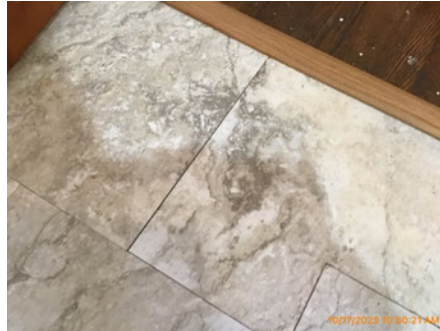
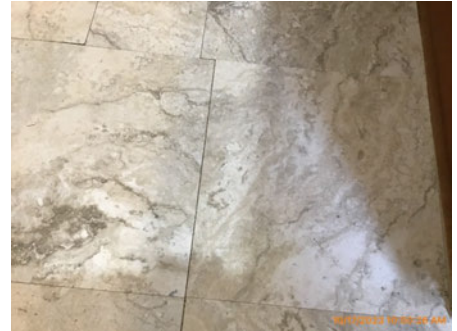
The vinyl floor covering has several split seams. We recommend that these areas be cleaned and then resealed. Once significant amounts of dirt and water penetrate under the flooring, this condition is very difficult to repair.

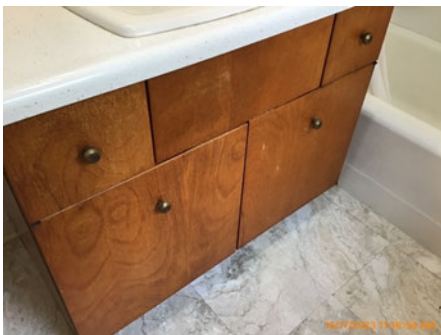
The cabinet surfaces are worn. We recommend they be refinished to restore their cosmetic appearance.

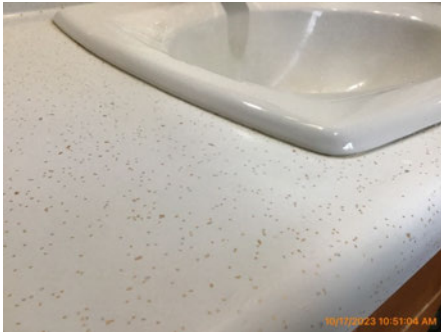
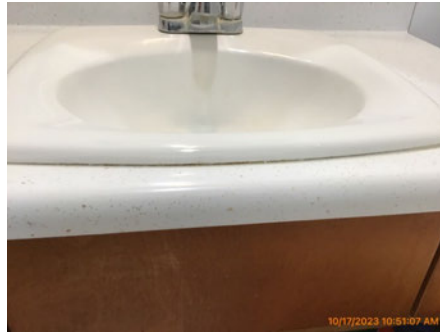
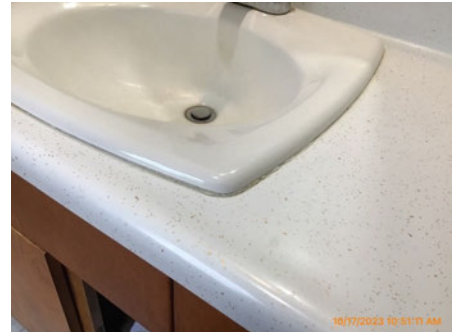
The caulking around the sink is deteriorated or missing. We recommend the sink be recaulked.

We suggest the use of a quality sealant such as 'GE Sanitary Silicone' or 'Dow Corning 786' for caulking. Latex and 'latex with silicone' sealants are inferior materials and their use is strongly discouraged.

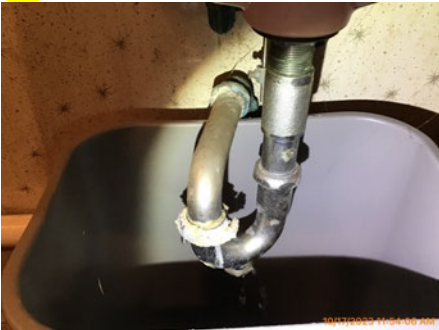
WARN The drain pipe fitting is leaking. We recommend it be repaired or replaced.

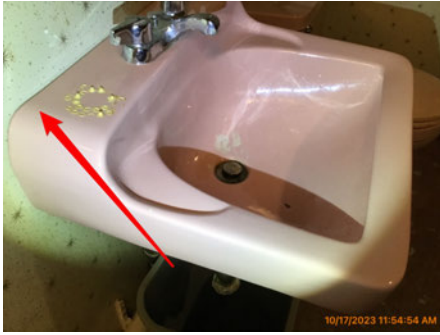
The wash basin is sagging at its attachment on the wall. We recommend the wash basin be securely fastened.

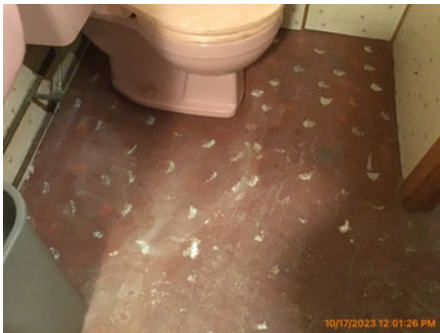
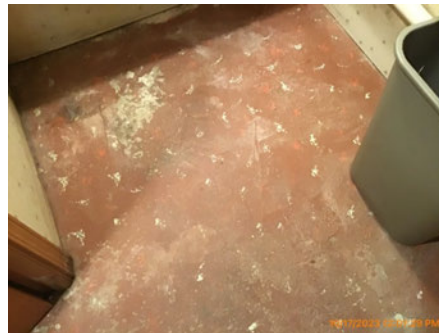
There is no finished flooring in this bathroom.

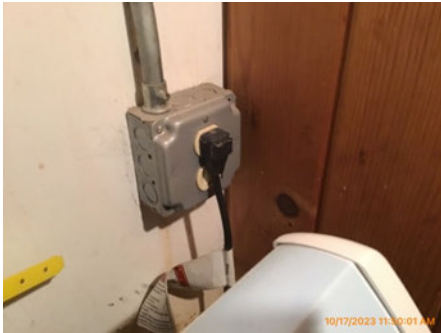
There is no GFCI (ground fault circuit interrupter) protection for this area. For an increased margin of safety, we recommend the installation of a GFCI receptacle.

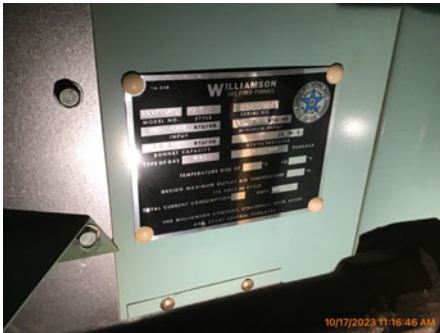
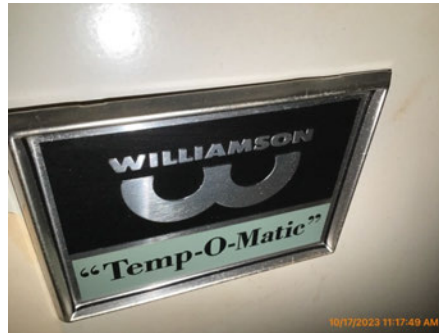
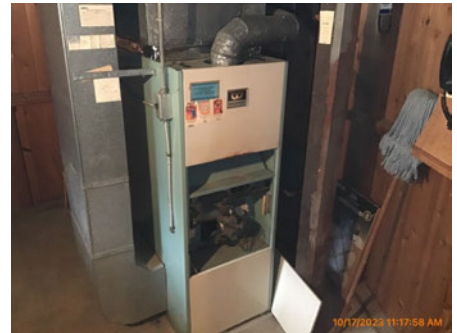
Energy source: Natural gas
 Furnace btu input rating: 100,000 btu's
 Age: 44 years old
 Filter size: 16 x 25 x 1 inch
 Manufacturer: Williamson

UPG This heating unit is 37 years old. The normal life of a forced air furnace is 25 years. Although still operating, the need for replacement should be expected in the near future.

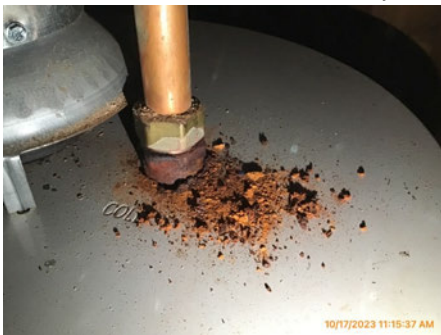
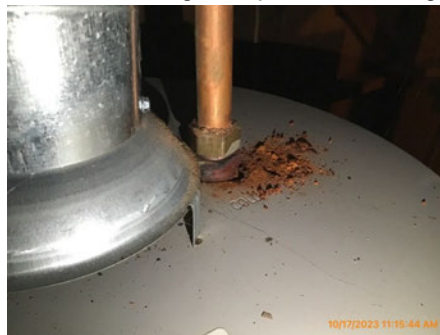
The water connections are heavily corroded and show signs of previous leakage. We recommend replacement.

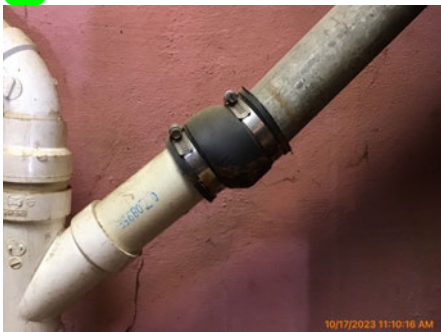
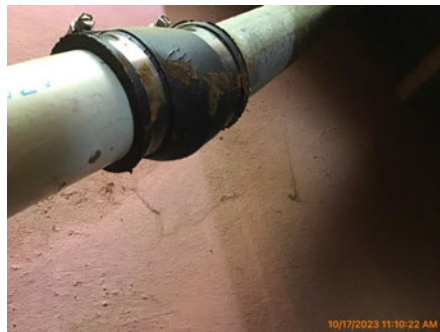
UPG There is deterioration on the rubber gasket. Preventative maintenance is recommended before leaks occur.

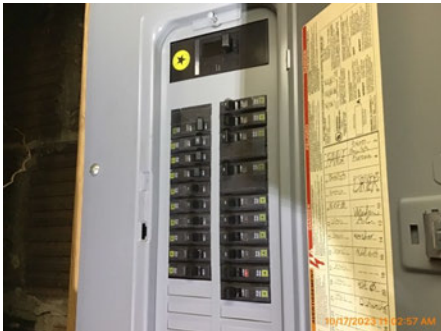
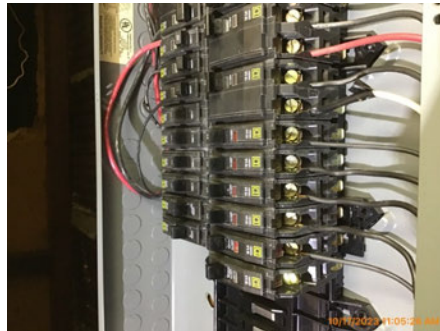
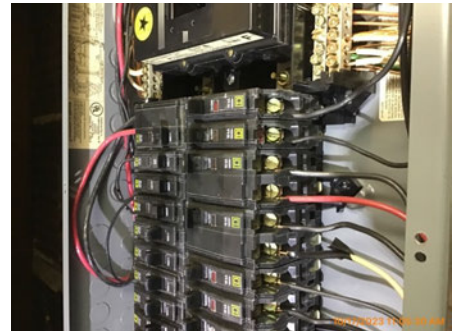
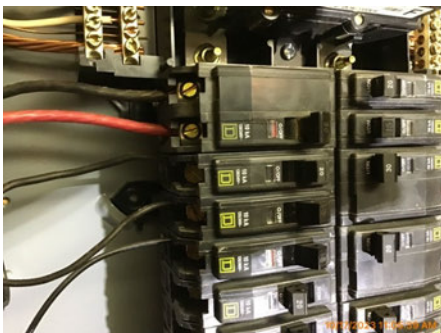
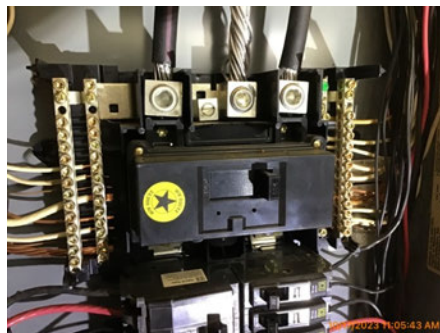
1CB MAIN PANEL

The main service panel is in good condition with circuitry installed and fused correctly.

The circuits in the panel are labeled. We did not verify the accuracy of the labeling, but it appears to be typical. When the opportunity arises, we suggest checking the labeling by actually operating the breakers.

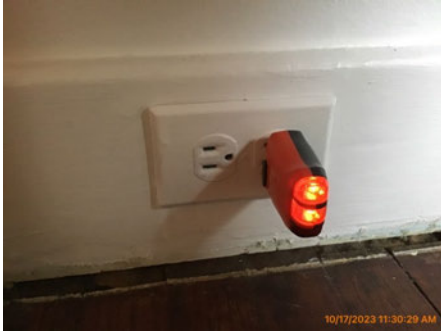
Middle bedroom

The receptacles throughout the structure are a combination of 2-wire and 3-wire types, with grounded and ungrounded circuitry, indicating installation at different times. The tested receptacles properly matched their wire type. If newer technology equipment (TV's and Computers) are used with these outlets. We recommend high quality surge protector strips be used instead of plugging the equipment directly into the wall.

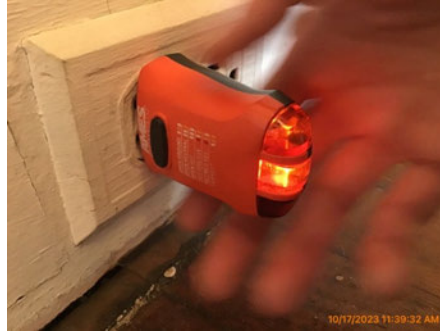
WARN Based upon our inspection of a representative number, we found enough deficiencies to warrant testing of every receptacle at a later date. Repair, replacement, and/or rewiring are recommended at all deficient locations.

DNGR A significant number of receptacles have been wired with reversed polarity. This creates a shock and short hazard and these receptacles should be repaired. We recommend all receptacles be checked for correct polarity, identified and repaired.

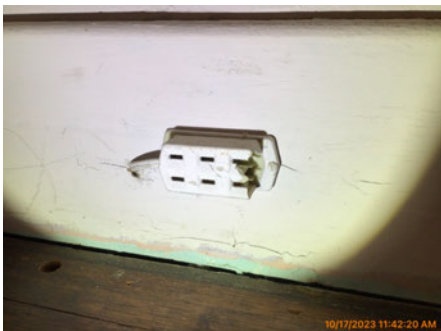
Front bedroom

Some of the receptacles are damaged, providing opportunity for contact with live electrical parts. We recommend all damaged receptacles be replaced.

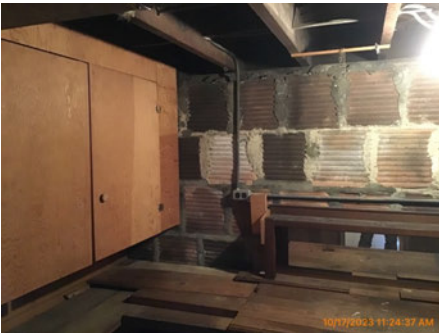
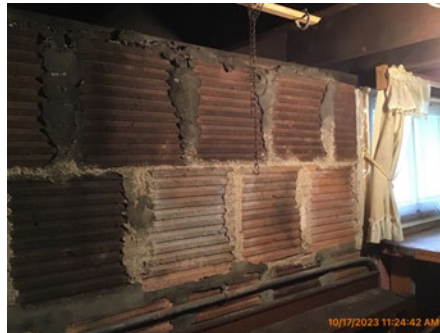
There is a condition known as 'efflorescence' on portions of the foundation walls. This whitish, fuzzy material is a 'salt' deposit left when moisture in the foundation evaporates on the inside of the foundation.

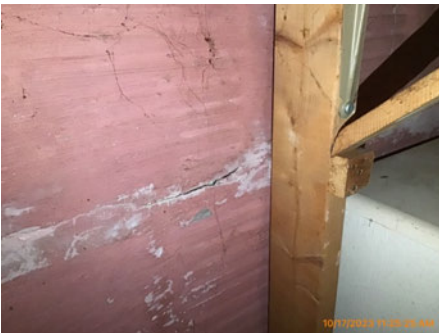
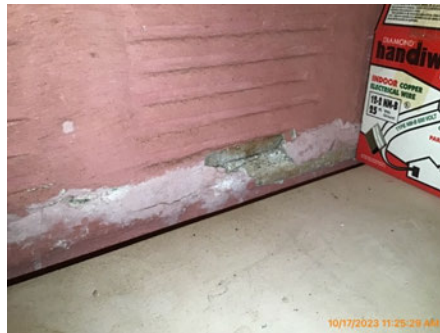
The foundation walls have a surface scaling known as 'spalling', which can result from deterioration of old, weak concrete or from a moisture reaction known as 'sulfating'. We find the concrete still serviceable but we recommend monitoring.

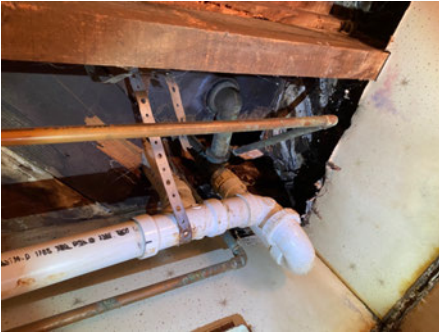
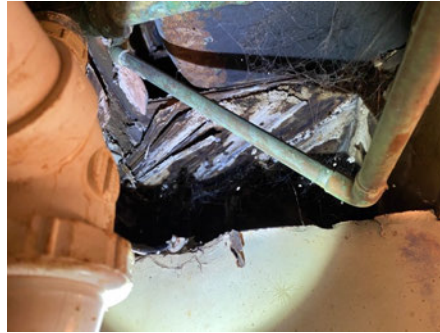
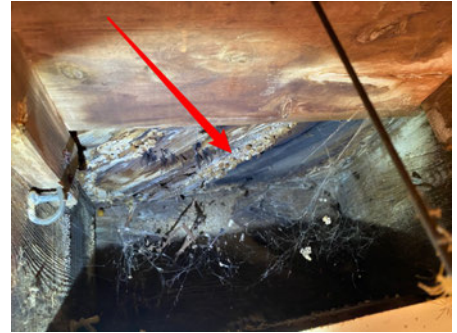
Fungal growth

WARN Generally, the subflooring is in good condition. However, the subfloor beneath the shower stall is damaged. There is current fungal growth in this area which should be cleaned and chemically treated. We recommend the subflooring be repaired and all damaged material replaced.
