Confidential Inspection Report

Tuesday, October 17, 2023

Inspector, Anton E. Britting
J.P.I. Inspections, LLC

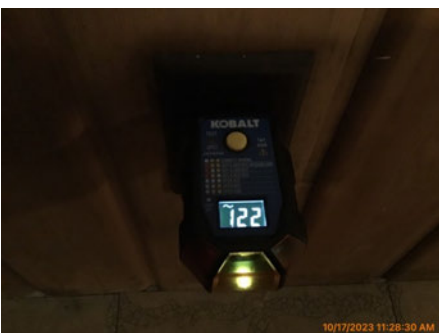
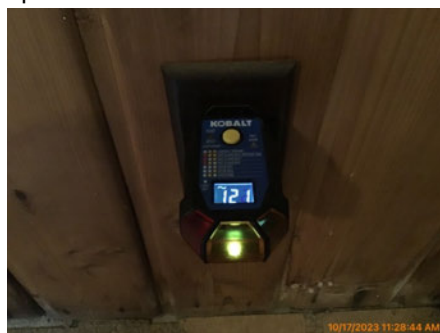
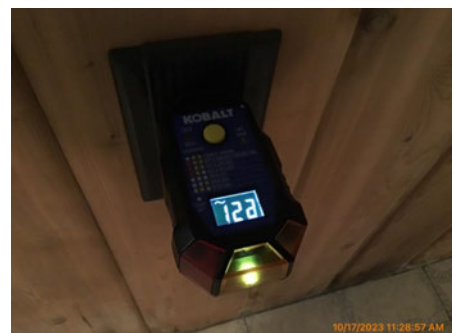
There is no GFCI (ground fault circuit interrupter) protection for this area. For an increased margin of safety, we recommend the installation of a GFCI receptacle.

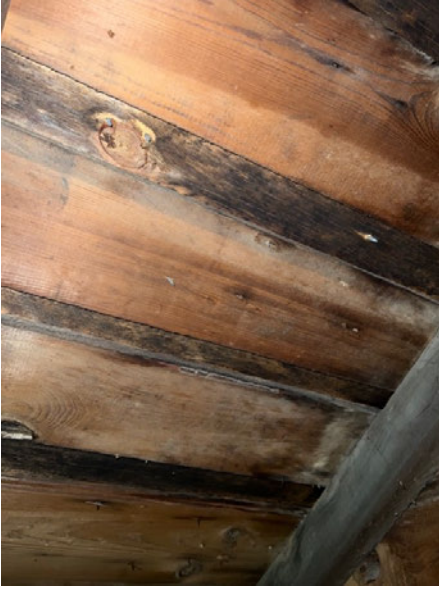
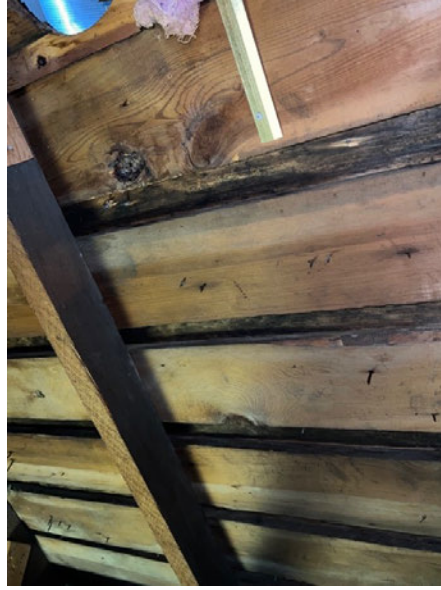
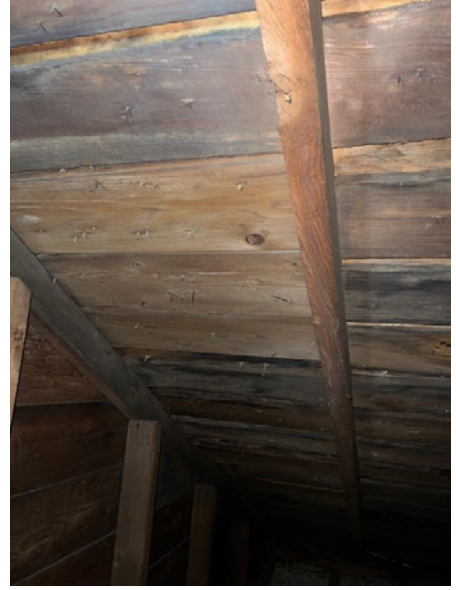
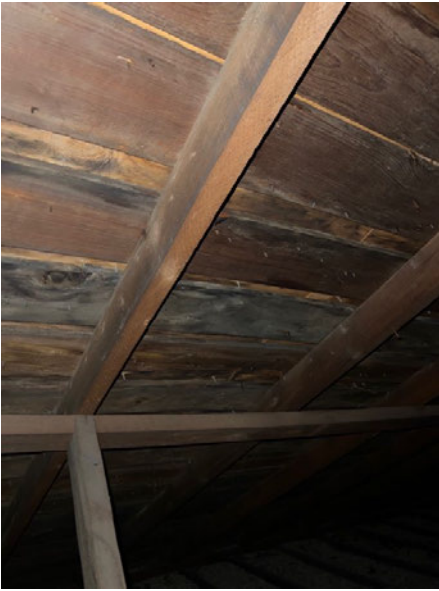
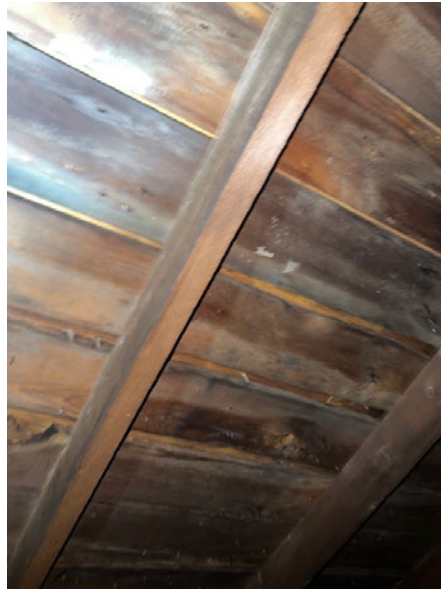
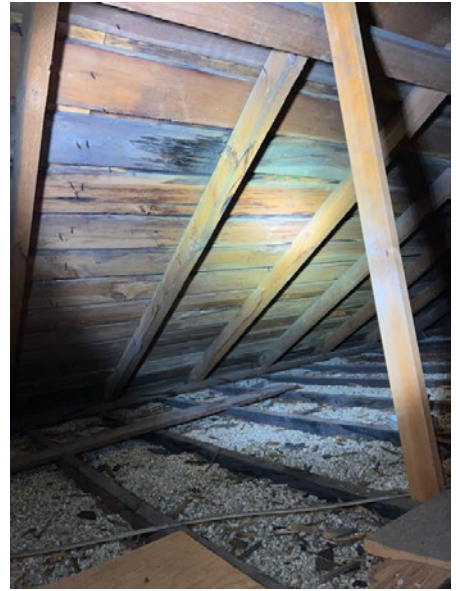
The roof sheathing is plywood nailed over a previously installed layer of skip sheathing.

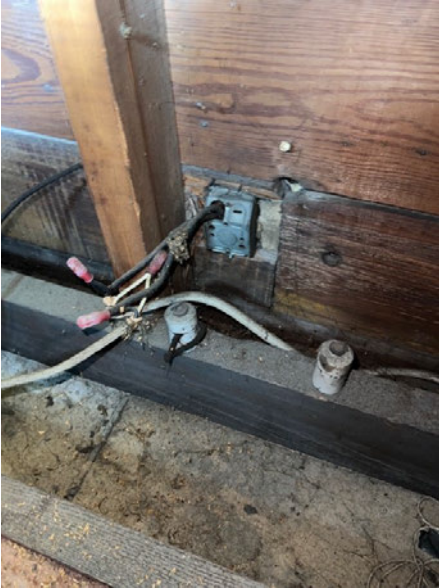
Running splices, which are improper connections outside of a junction box, were observed. We recommend connections be joined with approved connectors inside a junction box to prevent accidental contact or mechanical damage.

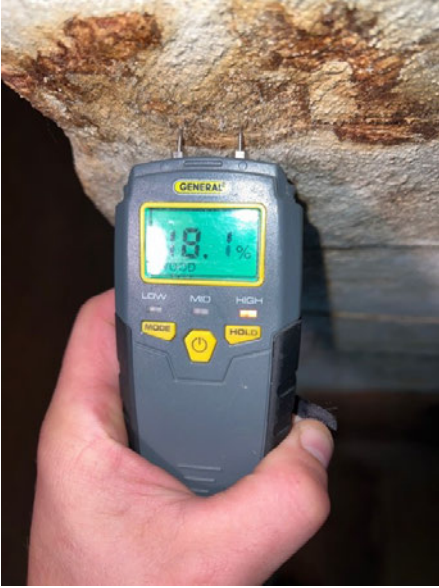
The chimney was moist to the touch in the attic.

WARN Some leak evidence was apparent around the brick chimney. The exposed brick in the attic has been covered with a cement parging. The cement parging is failing several areas suggesting that moisture is permeating through the brick chimney. We highly recommend attention to flashings around chimney to and tuckpoint mortar maintenance to the brick and mortar above the rooftop as described in the roofing section of this report.

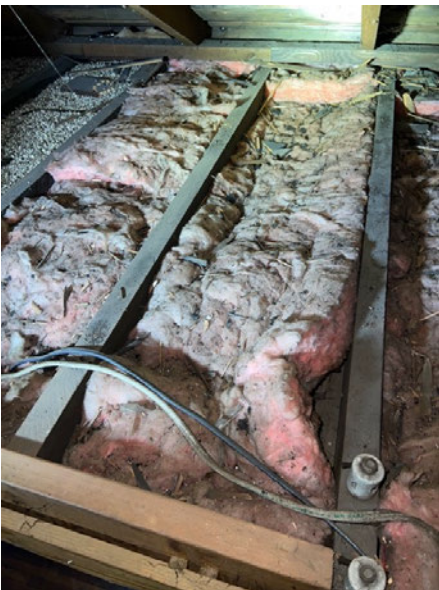
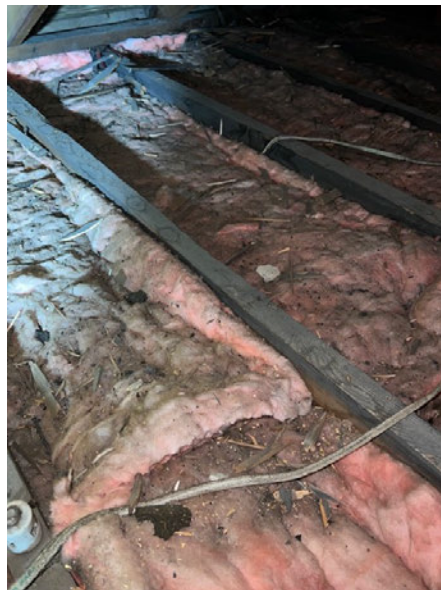
ATTIC INSULATION

Portions of the attic has fiberglass batt insulation.

Most of the attic is insulated with vermiculite. This type of insulation is know to have asbestos. It is recommended that all of the vermiculite be removed from the attic and new cellulose or fiberglass insulation be installed.

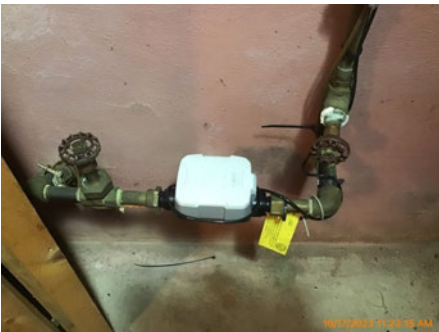
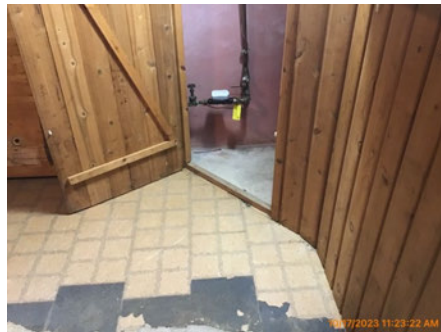
The domestic water supply main shut-off valve is in the basement.

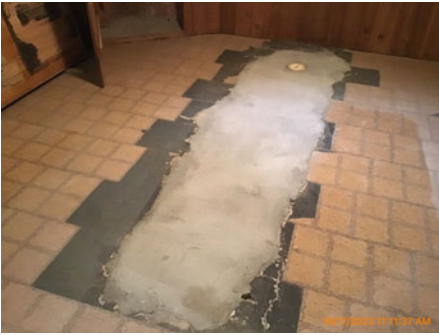
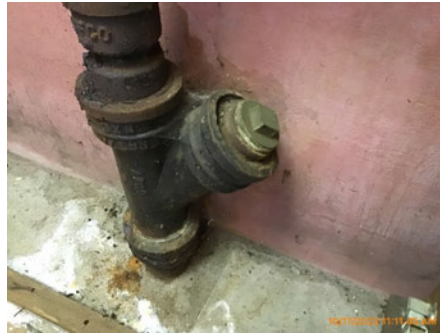
**SEWER CLEANOUT
PLUMBING**

The drain line clean-outs are located in the basement.

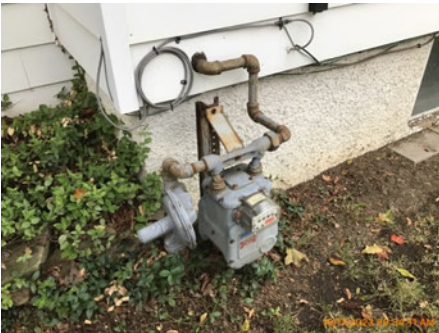
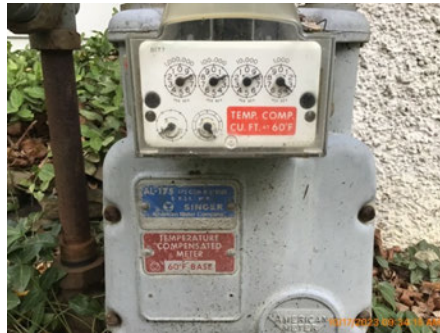
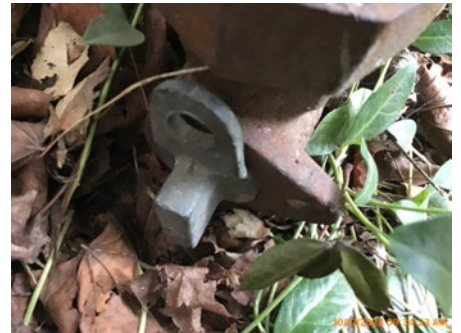
**GAS METER LOCATION
PLUMBING**

The gas meter is outside on the right side of the building. The main gas supply shutoff valve is located on the riser pipe between the ground and the meter. This valve should be turned 90 degrees (either way) in order to shut off the gas.

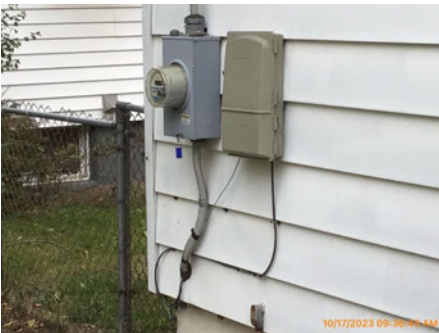
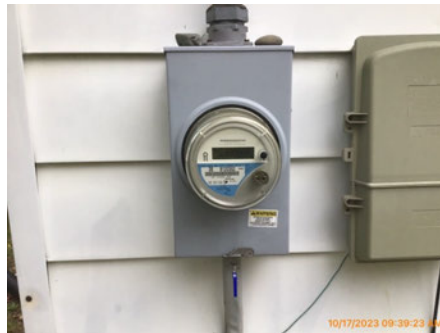
**ELECTRIC METER
ELECTRICAL SYSTEM**

The electric meter is outside on the rear of the building.

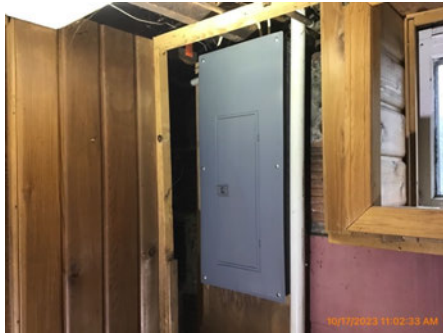
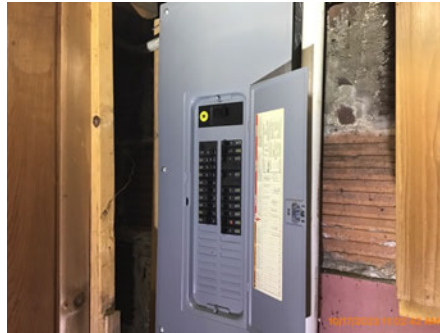
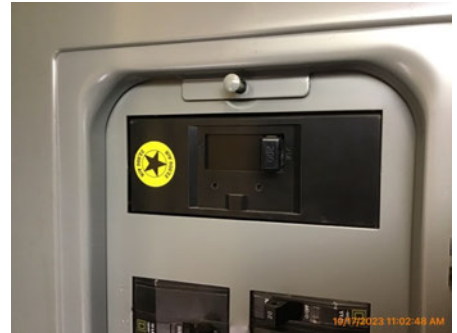
**MAIN DISCONNECT
ELECTRICAL SYSTEM**

The main disconnect is incorporated into the electrical service panel.
